Home Report

Single Survey

Property address	4 Princess Crescent Paisley PA1 3SL
-------------------------	---

Date of inspection	27/08/2024
---------------------------	------------

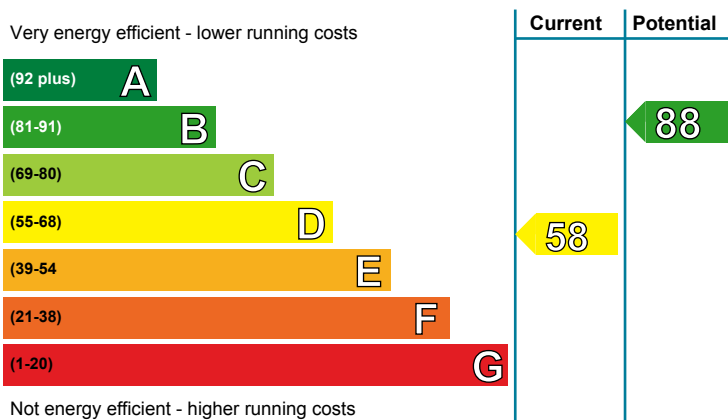
Energy Efficiency Rating

This graph shows the current efficiency of your home, taking into account both energy efficiency and fuel costs. The higher this rating, the lower your fuel bills are likely to be.

Your current rating is **band D (58)**. The average rating for EPCs in Scotland is **band D (61)**.

The potential rating shows the effect of undertaking all of the improvement measures listed within your recommendations report.

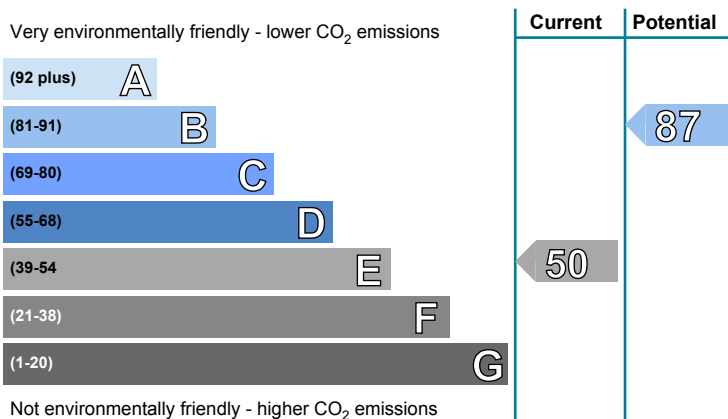
Environmental Impact (CO₂) Rating

This graph shows the effect of your home on the environment in terms of carbon dioxide (CO₂) emissions. The higher the rating, the less impact it has on the environment.
