Home Report

Scottish
Single Survey

Property address	0/1 6 Byres Crescent Paisley PA3 4RR
Customer	Executors of Dorothy Caldwell
Customer address	0/1 6 Byres Crescent Paisley PA3 4RR
Prepared by	Shepherd Chartered Surveyors
Date of inspection	08/01/2025

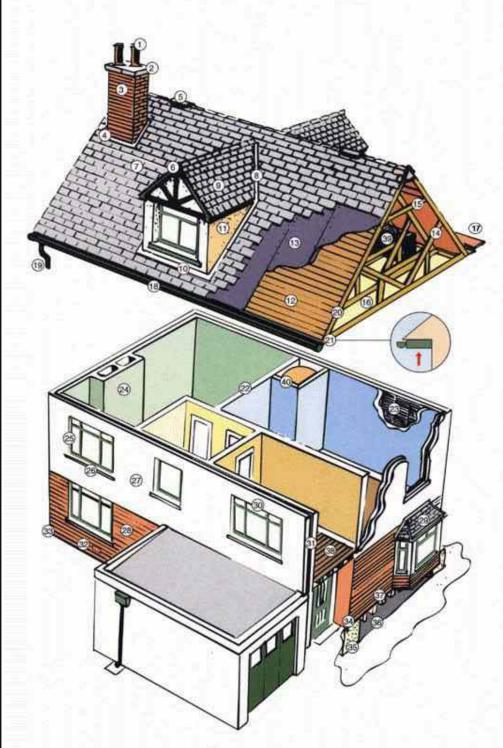
Sectional Diagram showing elements of a typical house

Reference may be made in this report to some or all of the above component parts of the property. This diagram may assist you in locating and understanding these items.

- 1) Chimney pots
- 2) Coping stone
- 3) Chimney head
- (4) Flashing
- 5) Ridge ventilation
- 6 Ridge board
- (7) Slates / tiles
- 8 Valley guttering
- 9 Dormer projection
- 10 Dormer flashing
- 11) Dormer cheeks
- (12) Sarking
- (13) Roof felt
- (14) Trusses
- (15) Collar
- 16) Insulation
- (17) Parapet gutter
- 18) Eaves guttering
- (19) Rainwater downpipe
- 20) Verge boards/skews
- 21) Soffit boards
- 22) Partition wall
- 23) Lath / plaster
- (24) Chimney breast
- 25) Window pointing
- 26) Window sills
- 27) Rendering
- (28) Brickwork / pointing
- 29 Bay window projection
- (30) Lintels
- (31) Cavity walls / wall ties
- 32) Subfloor ventilator
- (33) Damp proof course
- 34) Base course
- 35) Foundations
- 36) Solum
- 37) Floor joists
- 38) Floorboards
- 9) Water tank
- 40 Hot water tank
