Home Report

Single Survey

Property address	15a Courthill Street Dalry KA24 5BN
Customer	Mr R Telford
Customer address	15a Courthill Street Dalry KA24 5BN
Prepared by	Shepherd Chartered Surveyors
Date of inspection	30/01/2026

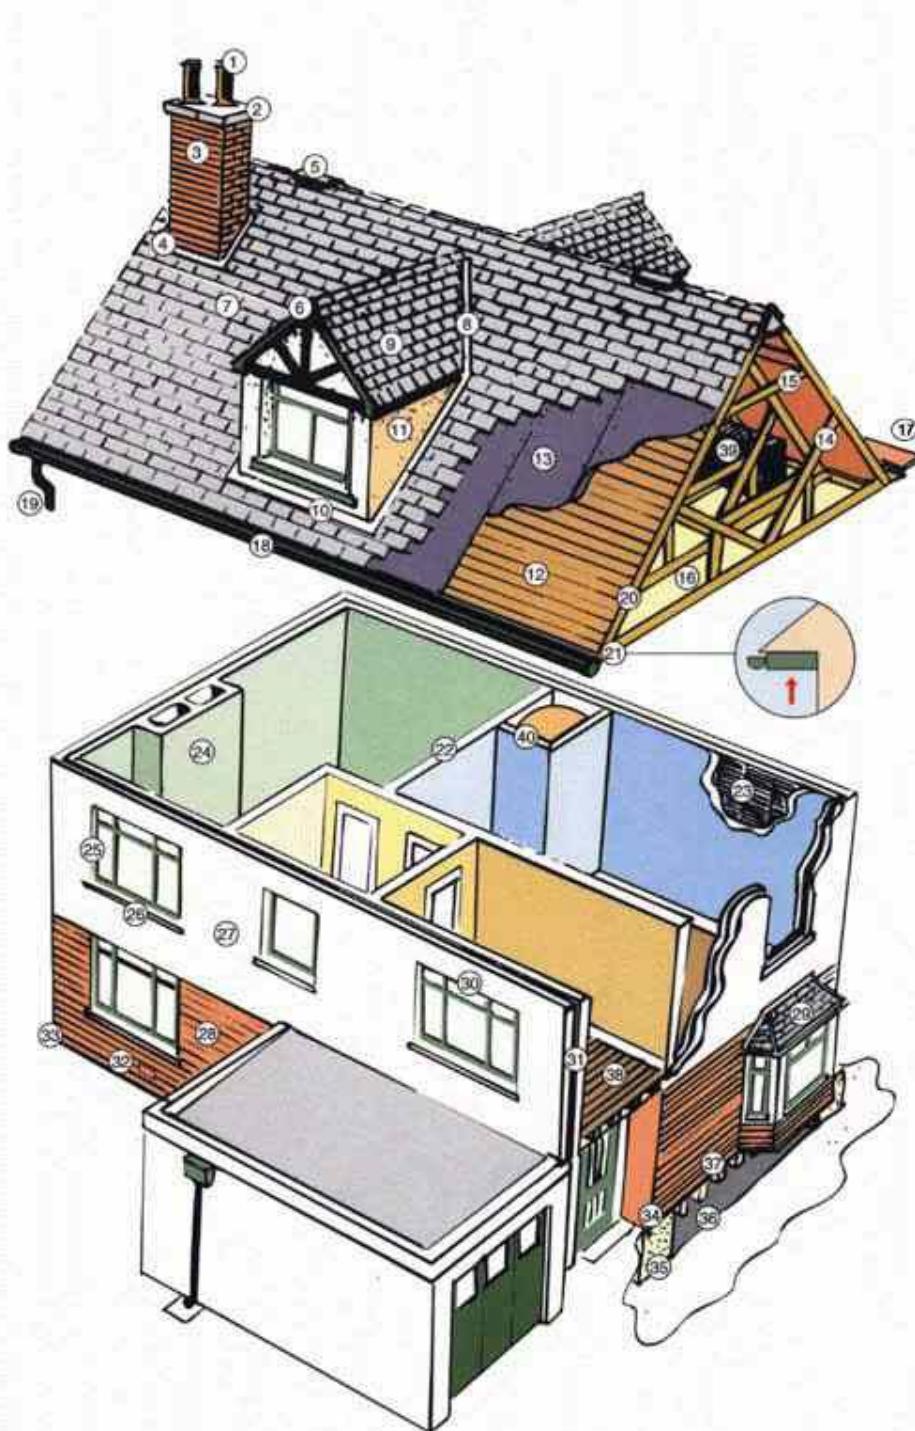
Sectional Diagram showing elements of a typical house

- 1 Chimney pots
- 2 Coping stone
- 3 Chimney head
- 4 Flashing
- 5 Ridge ventilation
- 6 Ridge board
- 7 Slates / tiles
- 8 Valley guttering
- 9 Dormer projection
- 10 Dormer flashing
- 11 Dormer cheeks
- 12 Sarking
- 13 Roof felt
- 14 Trusses
- 15 Collar
- 16 Insulation
- 17 Parapet gutter
- 18 Eaves guttering
- 19 Rainwater downpipe
- 20 Verge boards /skews
- 21 Soffit boards
- 22 Partition wall
- 23 Lath / plaster
- 24 Chimney breast
- 25 Window pointing
- 26 Window sills
- 27 Rendering
- 28 Brickwork / pointing
- 29 Bay window projection
- 30 Lintels
- 31 Cavity walls / wall ties
- 32 Subfloor ventilator
- 33 Damp proof course
- 34 Base course
- 35 Foundations
- 36 Solum
- 37 Floor joists
- 38 Floorboards
- 39 Water tank
- 40 Hot water tank

Reference may be made in this report to some or all of the above component parts of the property. This diagram may assist you in locating and understanding these items.
