Home Report

Scottish Single Survey

Property address	2/2 136 Renfrew Street Glasgow G3 6RF
-------------------------	--

Prepared by	Shepherd Chartered Surveyors
--------------------	------------------------------

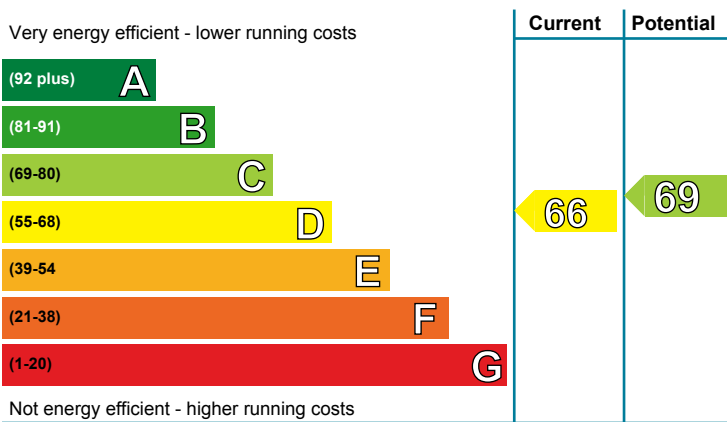
Energy Efficiency Rating

This graph shows the current efficiency of your home, taking into account both energy efficiency and fuel costs. The higher this rating, the lower your fuel bills are likely to be.

Your current rating is **band D (66)**. The average rating for EPCs in Scotland is **band D (61)**.

The potential rating shows the effect of undertaking all of the improvement measures listed within your recommendations report.

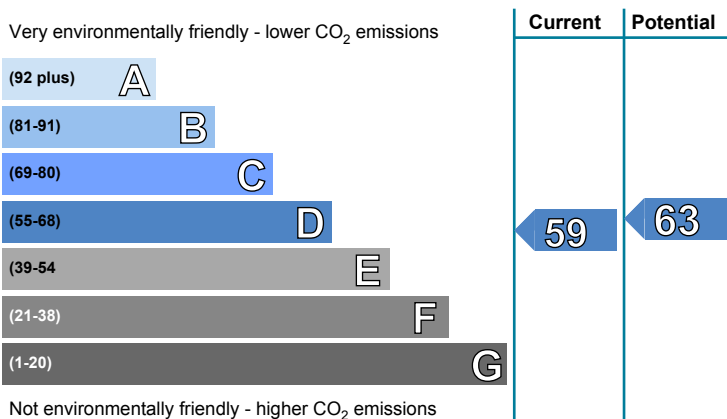
Environmental Impact (CO₂) Rating

This graph shows the effect of your home on the environment in terms of carbon dioxide (CO₂) emissions. The higher the rating, the less impact it has on the environment.
