YOUR ONESURVEY
HOME REPORT

59 Kenilworth
East Kilbride, Glasgow
G74 3PG

Single Survey

Surveyor Reference	LG/4401
Customer	Michelle Bradley
Selling address	59 Kenilworth East Kilbride, Glasgow G74 3PG
Date of Inspection	23/07/2024
Prepared by	David Donnachie, BSc MRICS Hamilton - Allied Surveyors Scotland Ltd

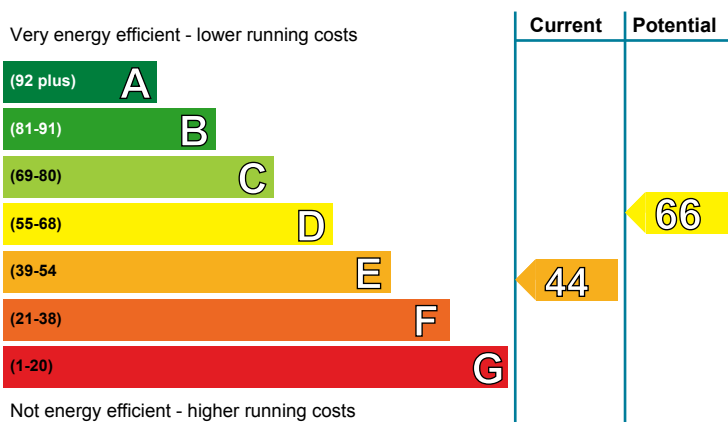
Energy Efficiency Rating

This graph shows the current efficiency of your home, taking into account both energy efficiency and fuel costs. The higher this rating, the lower your fuel bills are likely to be.

Your current rating is **band E (44)**. The average rating for EPCs in Scotland is **band D (61)**.

The potential rating shows the effect of undertaking all of the improvement measures listed within your recommendations report.

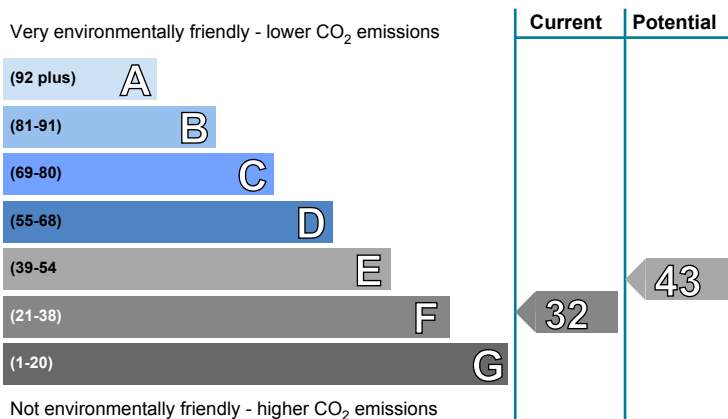
Environmental Impact (CO₂) Rating

This graph shows the effect of your home on the environment in terms of carbon dioxide (CO₂) emissions. The higher the rating, the less impact it has on the environment.
