**HOME**  
report

SINGLE SURVEY  
ENERGY REPORT  
PROPERTY QUESTIONNAIRE  
VALUATION REPORT

## Survey report on:

<b>Property Address</b>	4 Mcdonald Street Cumnock KA18 1DE
<b>Customer</b>	Mr M Muggridge & Mr J Armstrong
<b>Date of Inspection</b>	03/05/2024
<b>Prepared by</b>	Ross Macaulay Harvey Donaldson & Gibson Chartered Surveyors

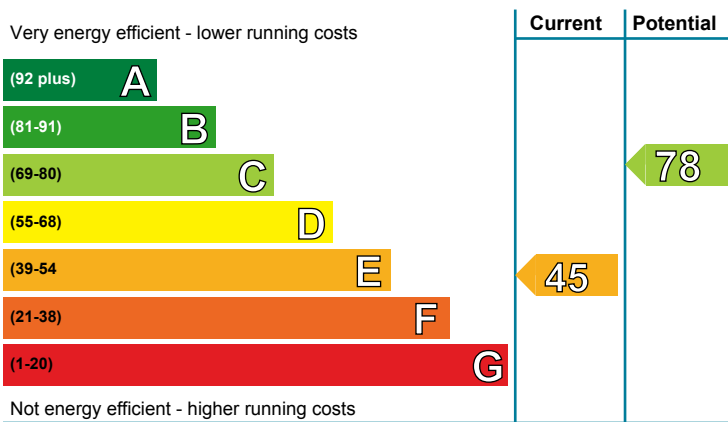
## Energy Efficiency Rating

This graph shows the current efficiency of your home, taking into account both energy efficiency and fuel costs. The higher this rating, the lower your fuel bills are likely to be.

Your current rating is **band E (45)**. The average rating for EPCs in Scotland is **band D (61)**.

The potential rating shows the effect of undertaking all of the improvement measures listed within your recommendations report.

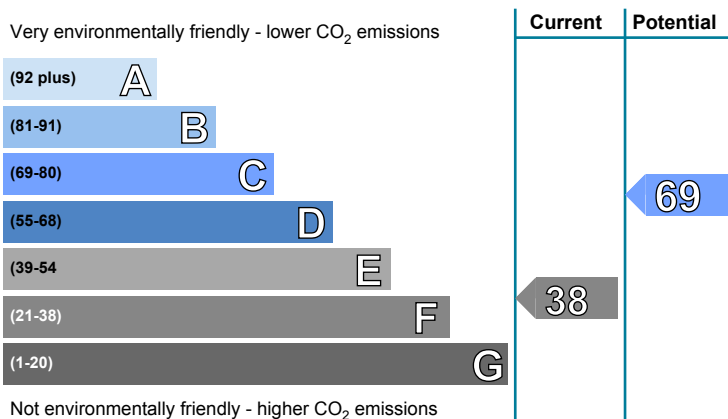
## Environmental Impact (CO<sub>2</sub>) Rating

This graph shows the effect of your home on the environment in terms of carbon dioxide (CO<sub>2</sub>) emissions. The higher the rating, the less impact it has on the environment.
