YOUR ONESURVEY HOME REPORT

41 Oakbank Drive Cumnock KA18 1BA PREPARED FOR

Single Survey

Surveyor Reference	AE/4569
Customer	Andrea New
Selling address	41 Oakbank Drive
	Cumnock
	KA18 1BA
Date of Inspection	24/04/2025
Prepared by	Mark Shanks, BSc MRICS
	Ayr - Allied Surveyors Scotland Ltd

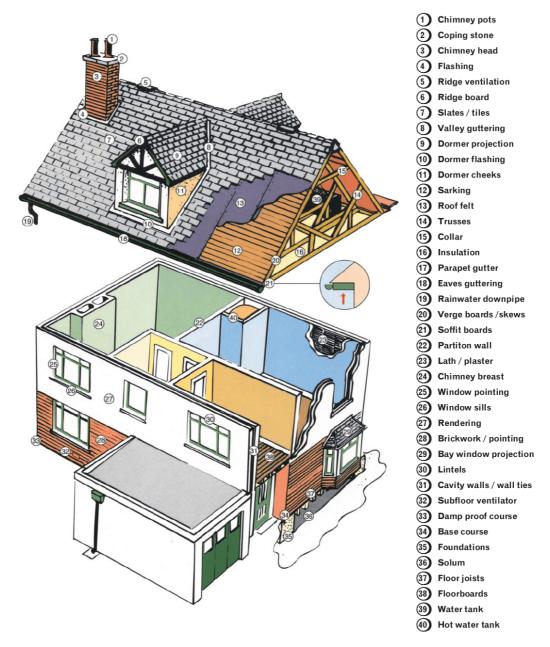
Sectional Diagram showing elements of a typical house

Reference may be made in this report to some or all of the above component parts of the property. This diagram may assist you in locating and understanding these items.
