HOME REPORT

Energy Performance Certificate (EPC)

FLAT 2/2 , 13 HAVELOCK STREET, GLASGOW, G11 5JB

Single Survey

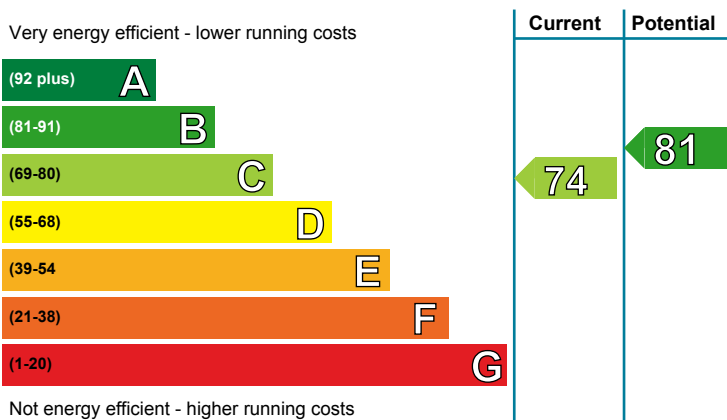
Energy Efficiency Rating

This graph shows the current efficiency of your home, taking into account both energy efficiency and fuel costs. The higher this rating, the lower your fuel bills are likely to be.

Your current rating is **band C (74)**. The average rating for EPCs in Scotland is **band D (61)**.

The potential rating shows the effect of undertaking all of the improvement measures listed within your recommendations report.
