HOME REPORT

Energy Performance Certificate (EPC)

FLAT 2/2 , 6 KENNOWAY DRIVE, GLASGOW, G11 7UB

Dwelling type: Mid-floor flat
Date of assessment: 28 August 2024
Date of certificate: 29 August 2024
Total floor area: 47 m²
Primary Energy Indicator: 206 kWh/m²/year

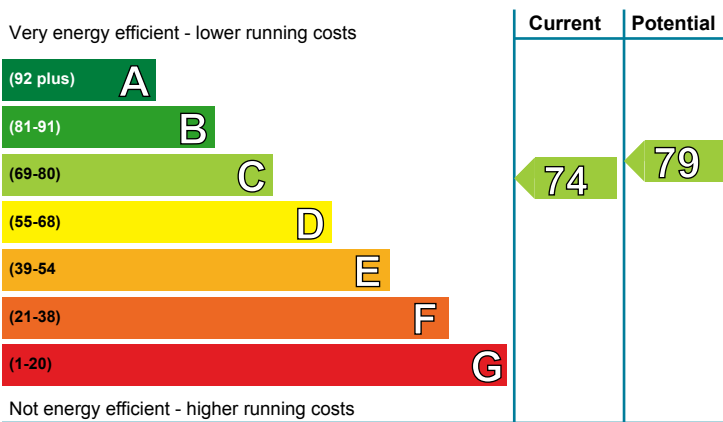
Energy Efficiency Rating

This graph shows the current efficiency of your home, taking into account both energy efficiency and fuel costs. The higher this rating, the lower your fuel bills are likely to be.

Your current rating is **band C (74)**. The average rating for EPCs in Scotland is **band D (61)**.

The potential rating shows the effect of undertaking all of the improvement measures listed within your recommendations report.

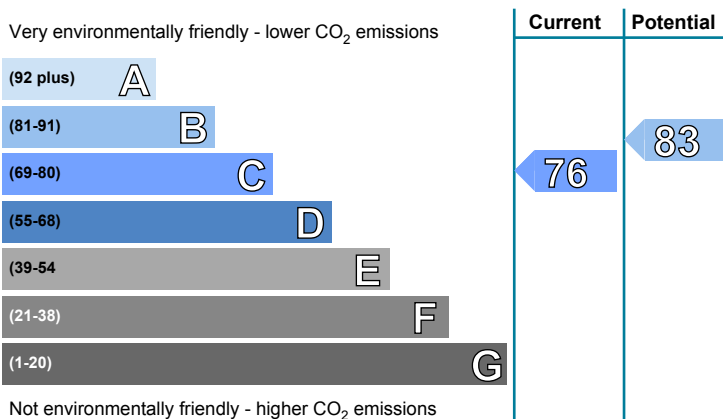
Environmental Impact (CO₂) Rating

This graph shows the effect of your home on the environment in terms of carbon dioxide (CO₂) emissions. The higher the rating, the less impact it has on the environment.

Your current rating is **band C (76)**. The average rating for EPCs in Scotland is **band D (59)**.

The potential rating shows the effect of undertaking all of the improvement measures listed within your recommendations report.
