HOME REPORT

37 TANNADICE AVENUE, GLASGOW, G52 3DE

Dwelling type: Top-floor flat
Date of assessment: 01 October 2024
Date of certificate: 03 October 2024
Total floor area: 73 m²
Primary Energy Indicator: 164 kWh/m²/year

Single Survey

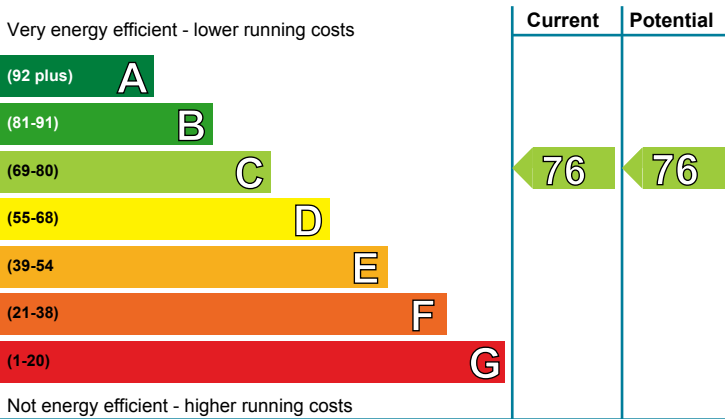
Energy Efficiency Rating

This graph shows the current efficiency of your home, taking into account both energy efficiency and fuel costs. The higher this rating, the lower your fuel bills are likely to be.

Your current rating is **band C (76)**. The average rating for EPCs in Scotland is **band D (61)**.

The potential rating shows the effect of undertaking all of the improvement measures listed within your recommendations report.

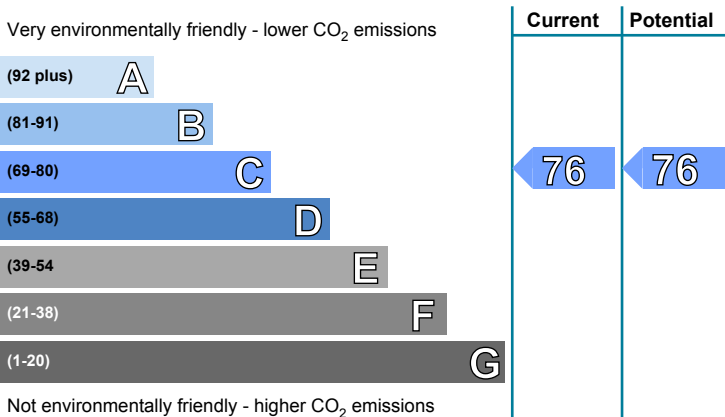
Environmental Impact (CO₂) Rating

This graph shows the effect of your home on the environment in terms of carbon dioxide (CO₂) emissions. The higher the rating, the less impact it has on the environment.

Your current rating is **band C (76)**. The average rating for EPCs in Scotland is **band D (59)**.

The potential rating shows the effect of undertaking all of the improvement measures listed within your recommendations report.
