# Home Report

**Property address:** Faroe  
Sourin  
Rousay  
Orkney

**Date of inspection:** 5<sup>th</sup> February 2021

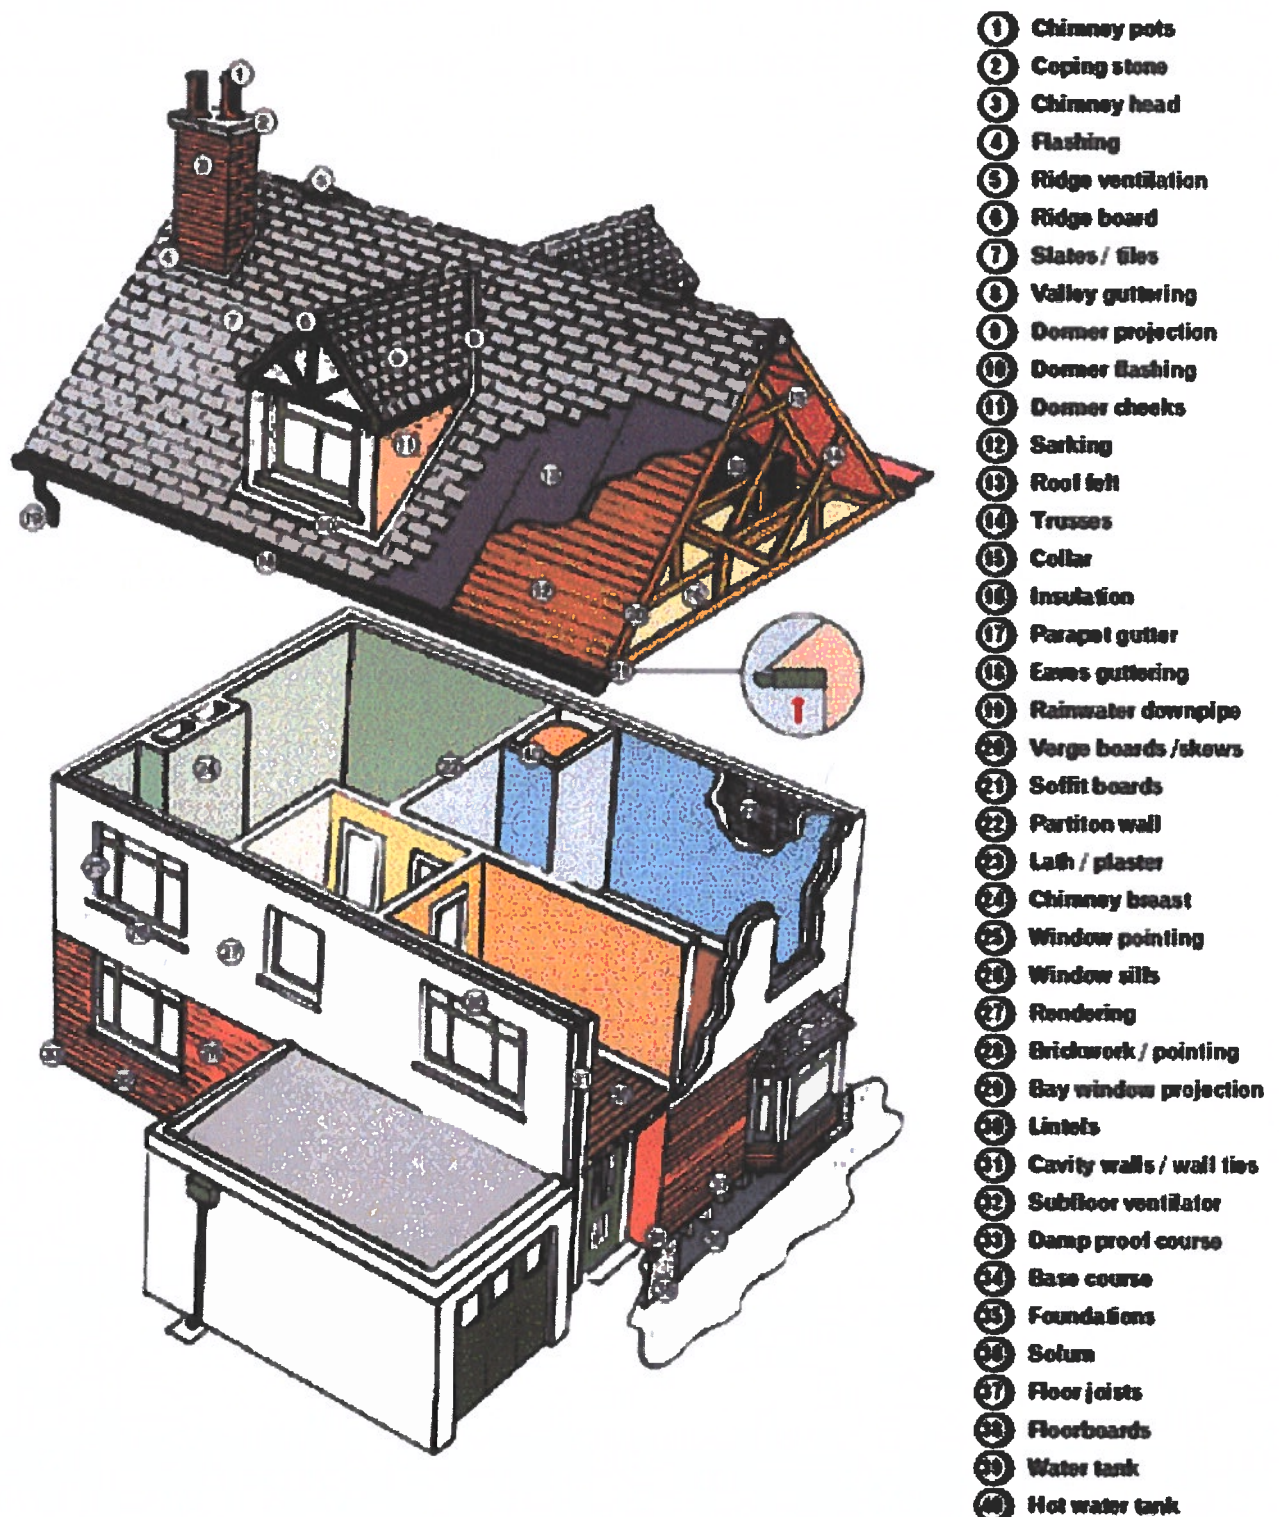
## Sectional diagram showing elements of a typical house

Reference may be made in this report to some or all of the above component parts of the property. This diagram may assist you in locating and understanding these terms.
