Home Report

LILLESHALL HOUSE LILLIESHALL
STREET

HELMSDALE
KW8 6JQ

Energy Performance Certificate (EPC)

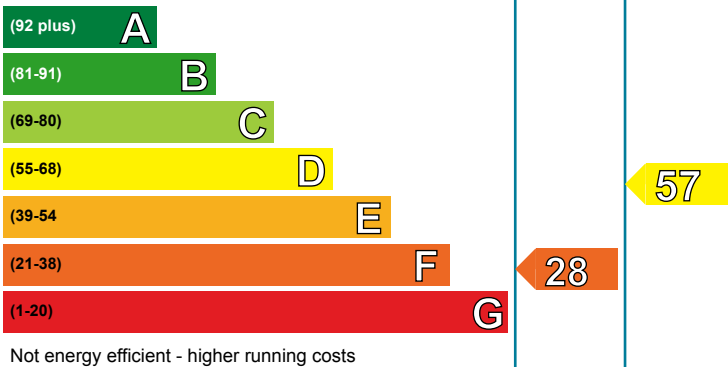
Energy Efficiency Rating

This graph shows the current efficiency of your home, taking into account both energy efficiency and fuel costs. The higher this rating, the lower your fuel bills are likely to be.

Your current rating is **band F (28)**. The average rating for EPCs in Scotland is **band D (61)**.

The potential rating shows the effect of undertaking all of the improvement measures listed within your recommendations report.

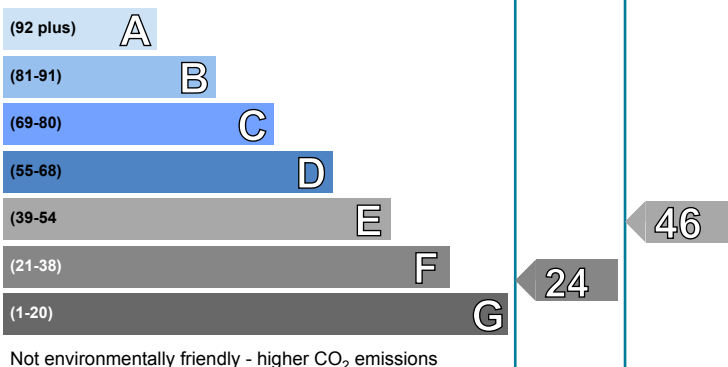
Environmental Impact (CO₂) Rating

This graph shows the effect of your home on the environment in terms of carbon dioxide (CO₂) emissions. The higher the rating, the less impact it has on the environment.

The potential rating shows the effect of undertaking all of the improvement measures listed within your recommendations report.

The average Scottish household produces about 6 tonnes of carbon dioxide every year. Based on this assessment, heating and lighting this home currently produces approximately 15 tonnes of carbon dioxide every year. Adopting recommendations in this report can reduce emissions and protect the environment. If you were to install all of these recommendations this could reduce emissions by 5.4 tonnes per year. You could reduce emissions even more by switching to renewable energy sources.
