Home Report

BANK HOUSE VICTORIA ROAD

BRORA
KW9 6QN

Energy Performance Certificate (EPC)

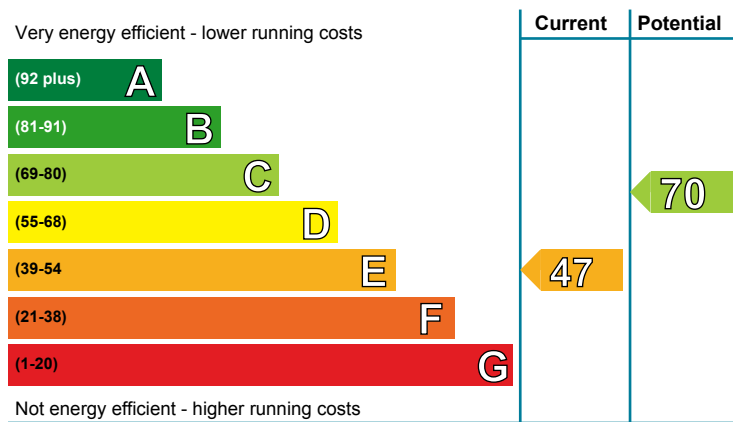
Energy Efficiency Rating

This graph shows the current efficiency of your home, taking into account both energy efficiency and fuel costs. The higher this rating, the lower your fuel bills are likely to be.

Your current rating is **band E (47)**. The average rating for EPCs in Scotland is **band D (61)**.

The potential rating shows the effect of undertaking all of the improvement measures listed within your recommendations report.

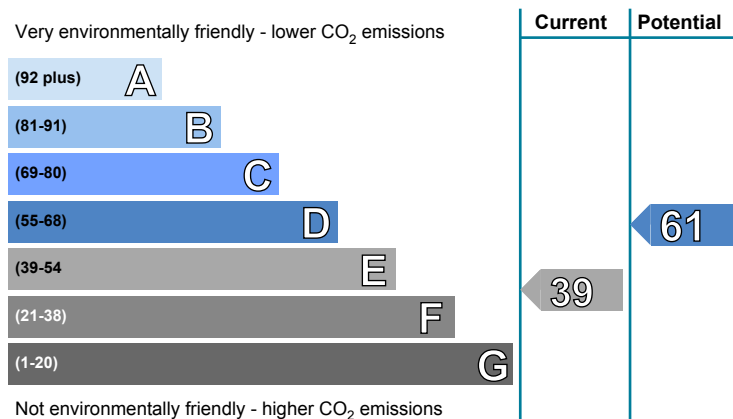
Environmental Impact (CO₂) Rating

This graph shows the effect of your home on the environment in terms of carbon dioxide (CO₂) emissions. The higher the rating, the less impact it has on the environment.

Your current rating is **band E (39)**. The average rating for EPCs in Scotland is **band D (59)**.

The potential rating shows the effect of undertaking all of the improvement measures listed within your recommendations report.
