Home Report

Scottish Single Survey

Property address	2 Carlung House Carlung Estate West Kilbride KA23 9PU
Customer	Craig Millar
Customer address	2 Carlung House Carlung Estate West Kilbride KA23 9PU
Prepared by	Shepherd Chartered Surveyors
Date of inspection	17/01/2024

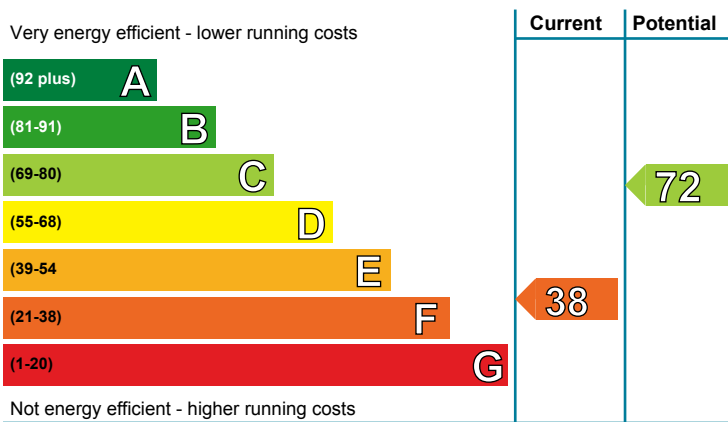
Energy Efficiency Rating

This graph shows the current efficiency of your home, taking into account both energy efficiency and fuel costs. The higher this rating, the lower your fuel bills are likely to be.

Your current rating is **band F (38)**. The average rating for EPCs in Scotland is **band D (61)**.

The potential rating shows the effect of undertaking all of the improvement measures listed within your recommendations report.
