# Home Report

# Scottish Single Survey

<b>Property address</b>	3 Morland House Long Hill Skelmorlie PA17 5DS
-------------------------	--

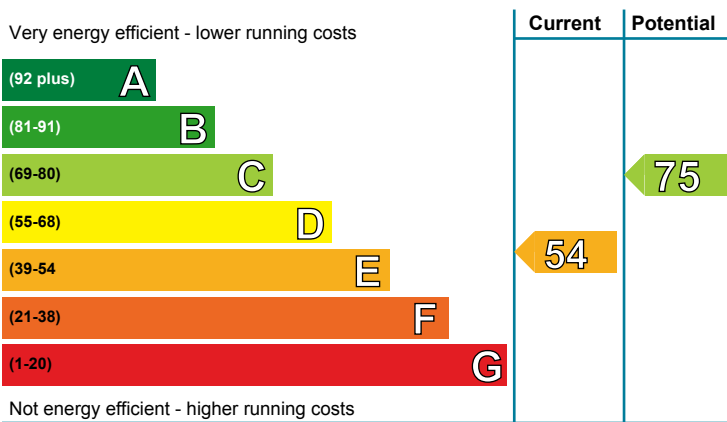
## Energy Efficiency Rating

This graph shows the current efficiency of your home, taking into account both energy efficiency and fuel costs. The higher this rating, the lower your fuel bills are likely to be.

Your current rating is **band E (54)**. The average rating for EPCs in Scotland is **band D (61)**.

The potential rating shows the effect of undertaking all of the improvement measures listed within your recommendations report.

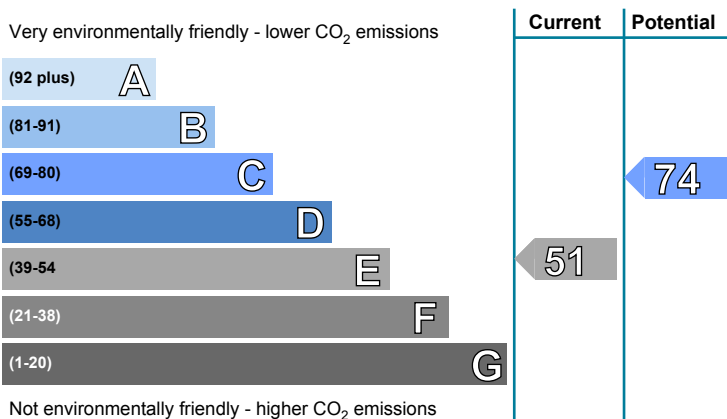
## Environmental Impact (CO<sub>2</sub>) Rating

This graph shows the effect of your home on the environment in terms of carbon dioxide (CO<sub>2</sub>) emissions. The higher the rating, the less impact it has on the environment.
