HOME REPORT

1A ARDROSSAN ROAD
SEAMILL
WEST KILBRIDE
KA23 9LZ

DM HALL
CHARTERED SURVEYORS

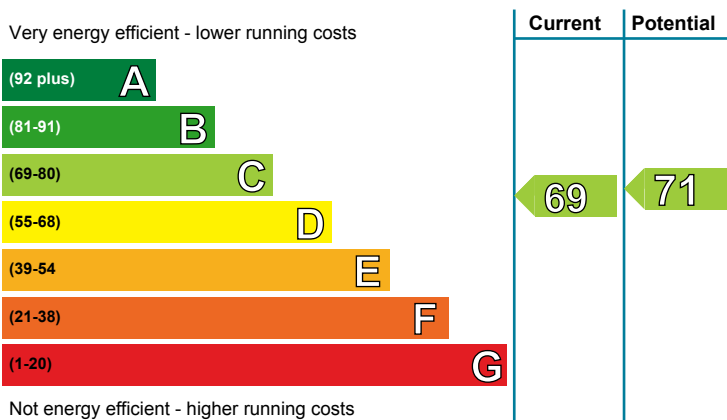
Energy Efficiency Rating

This graph shows the current efficiency of your home, taking into account both energy efficiency and fuel costs. The higher this rating, the lower your fuel bills are likely to be.

Your current rating is **band C (69)**. The average rating for EPCs in Scotland is **band D (61)**.

The potential rating shows the effect of undertaking all of the improvement measures listed within your recommendations report.

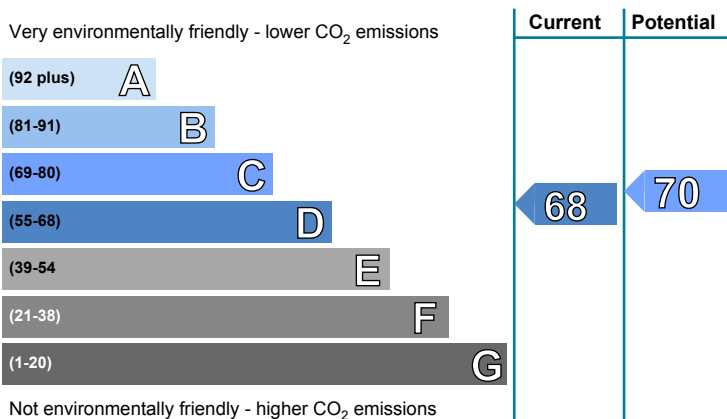
Environmental Impact (CO₂) Rating

This graph shows the effect of your home on the environment in terms of carbon dioxide (CO₂) emissions. The higher the rating, the less impact it has on the environment.

Your current rating is **band D (68)**. The average rating for EPCs in Scotland is **band D (59)**.

The potential rating shows the effect of undertaking all of the improvement measures listed within your recommendations report.
