Home Report

Scottish Single Survey

Property address	23a Summerlea Road Seamill West Kilbride KA23 9HP
-------------------------	--

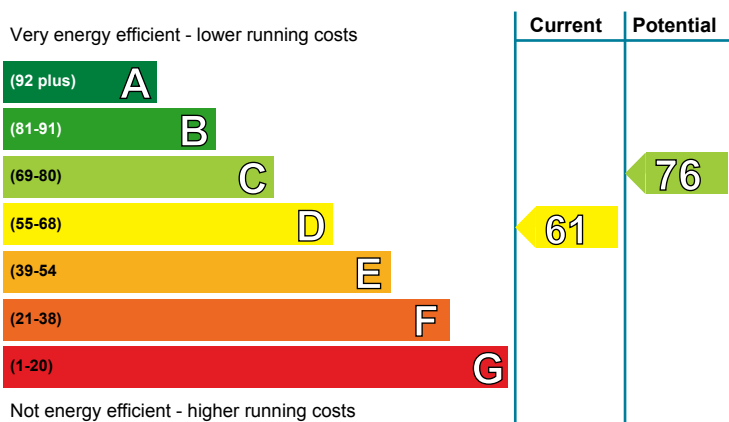
Energy Efficiency Rating

This graph shows the current efficiency of your home, taking into account both energy efficiency and fuel costs. The higher this rating, the lower your fuel bills are likely to be.

Your current rating is **band D (61)**. The average rating for EPCs in Scotland is **band D (61)**.

The potential rating shows the effect of undertaking all of the improvement measures listed within your recommendations report.

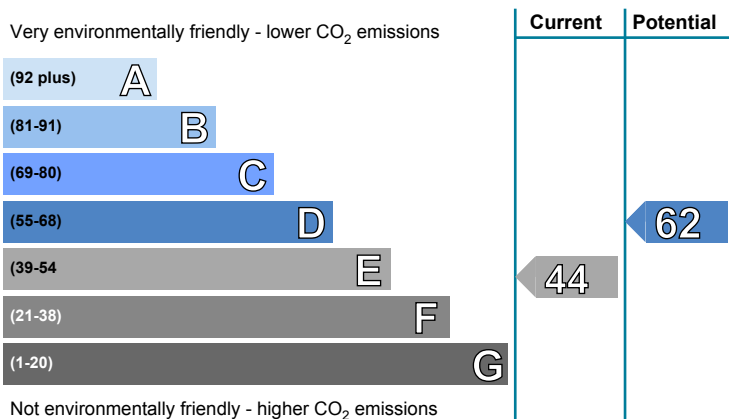
Environmental Impact (CO₂) Rating

This graph shows the effect of your home on the environment in terms of carbon dioxide (CO₂) emissions. The higher the rating, the less impact it has on the environment.
