HOME REPORT

4 MAY STREET
LARGS
KA30 8EB

Energy Performance Certificate (EPC)

4 MAY STREET, LARGS, KA30 8EB

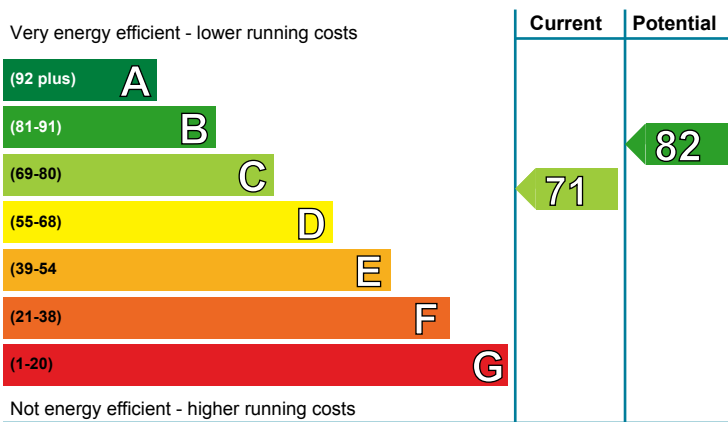
Energy Efficiency Rating

This graph shows the current efficiency of your home, taking into account both energy efficiency and fuel costs. The higher this rating, the lower your fuel bills are likely to be.

Your current rating is **band C (71)**. The average rating for EPCs in Scotland is **band D (61)**.

The potential rating shows the effect of undertaking all of the improvement measures listed within your recommendations report.
