Home Report

Scottish Single Survey

Single Survey

Property address	36 Dalry Road Beith KA15 1BA
Customer	Mr & Mrs S Smith
Customer address	36 Dalry Road Beith KA15 1BA
Prepared by	Shepherd Chartered Surveyors
Date of inspection	05/08/2024

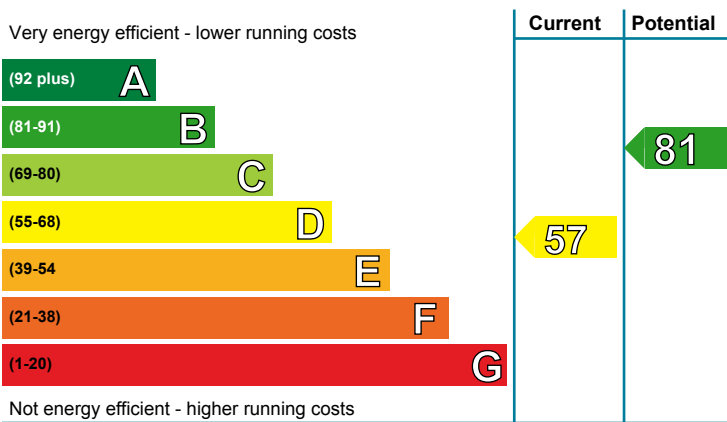
Energy Efficiency Rating

This graph shows the current efficiency of your home, taking into account both energy efficiency and fuel costs. The higher this rating, the lower your fuel bills are likely to be.

Your current rating is **band D (57)**. The average rating for EPCs in Scotland is **band D (61)**.

The potential rating shows the effect of undertaking all of the improvement measures listed within your recommendations report.

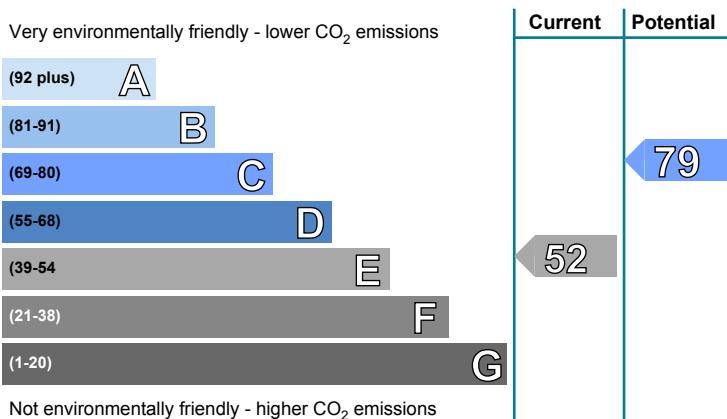
Environmental Impact (CO₂) Rating

This graph shows the effect of your home on the environment in terms of carbon dioxide (CO₂) emissions. The higher the rating, the less impact it has on the environment.
