HOME REPORT

WOOD VALE MAIN ROAD

FAIRLIE
LARGS
KA29 0DL

ENERGY PERFORMANCE CERTIFICATE

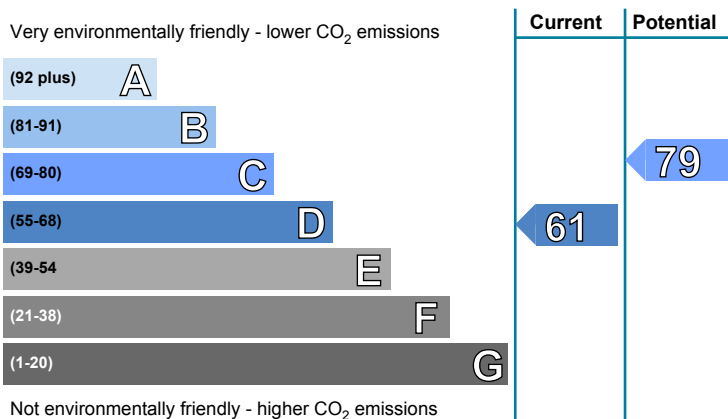
Environmental Impact (CO₂) Rating

This graph shows the effect of your home on the environment in terms of carbon dioxide (CO₂) emissions. The higher the rating, the less impact it has on the environment.

Your current rating is **band D (61)**. The average rating for EPCs in Scotland is **band D (59)**.

The potential rating shows the effect of undertaking all of the improvement measures listed within your recommendations report.

The average Scottish household produces about 6 tonnes of carbon dioxide every year. Based on this assessment, heating and lighting this home currently produces approximately 6.8 tonnes of carbon dioxide every year. Adopting recommendations in this report can reduce emissions and protect the environment. If you were to install all of these recommendations this could reduce emissions by 3.0 tonnes per year. You could reduce emissions even more by switching to renewable energy sources.
