HOME REPORT

CROEK COTTAGE CARLUNG ESTATE

WEST KILBRIDE
KA23 9PU

Energy Performance Certificate (EPC)

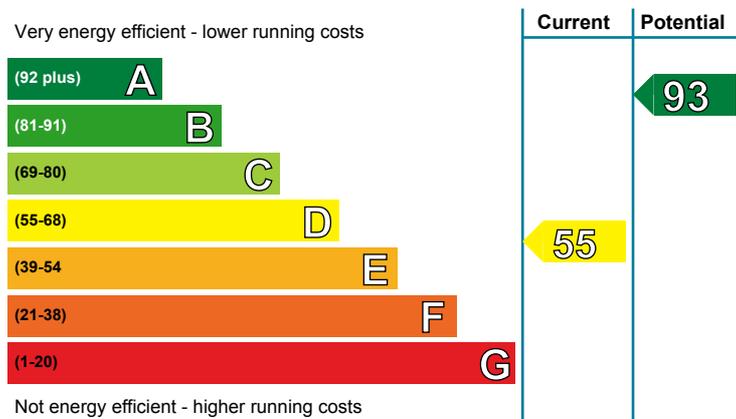
Energy Efficiency Rating

This graph shows the current efficiency of your home, taking into account both energy efficiency and fuel costs. The higher this rating, the lower your fuel bills are likely to be.

Your current rating is **band D (55)**. The average rating for EPCs in Scotland is **band D (61)**.

The potential rating shows the effect of undertaking all of the improvement measures listed within your recommendations report.

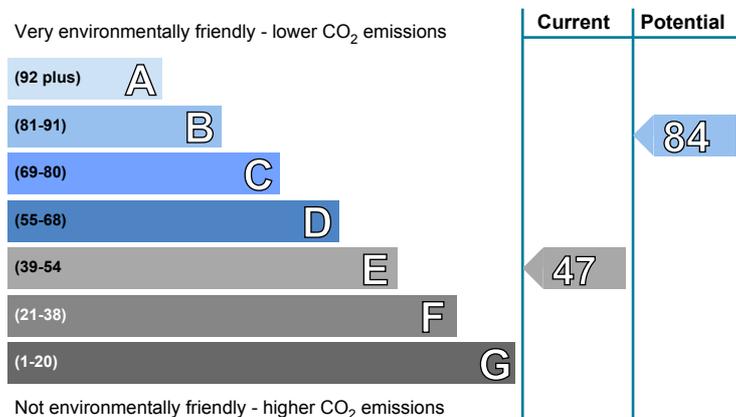
Environmental Impact (CO₂) Rating

This graph shows the effect of your home on the environment in terms of carbon dioxide (CO₂) emissions. The higher the rating, the less impact it has on the environment.

Your current rating is **band E (47)**. The average rating for EPCs in Scotland is **band D (59)**.

The potential rating shows the effect of undertaking all of the improvement measures listed within your recommendations report.

The average Scottish household produces about 6 tonnes of carbon dioxide every year. Based on this assessment, heating and lighting this home currently produces approximately 7.8 tonnes of carbon dioxide every year. Adopting recommendations in this report can reduce emissions and protect the environment. If you were to install all of these recommendations this could reduce emissions by 4.9 tonnes per year. You could reduce emissions even more by switching to renewable energy sources.
