HOME
report

SINGLE SURVEY
ENERGY REPORT
PROPERTY QUESTIONNAIRE
VALUATION REPORT

Single Survey

Property address	6 Main Street, Chryston, Glasgow, G69 9DH
-------------------------	--

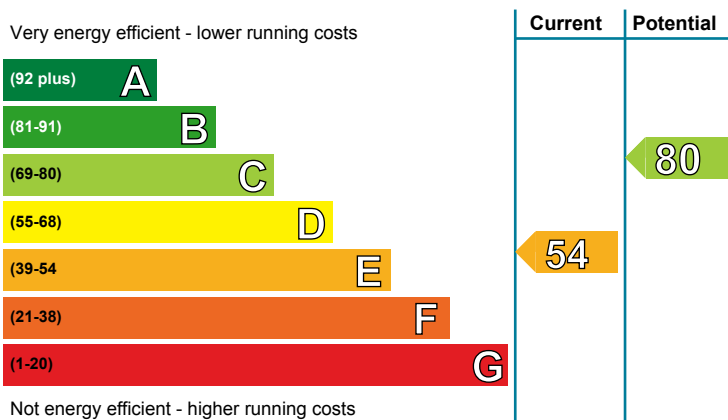
Energy Efficiency Rating

This graph shows the current efficiency of your home, taking into account both energy efficiency and fuel costs. The higher this rating, the lower your fuel bills are likely to be.

Your current rating is **band E (54)**. The average rating for EPCs in Scotland is **band D (61)**.

The potential rating shows the effect of undertaking all of the improvement measures listed within your recommendations report.

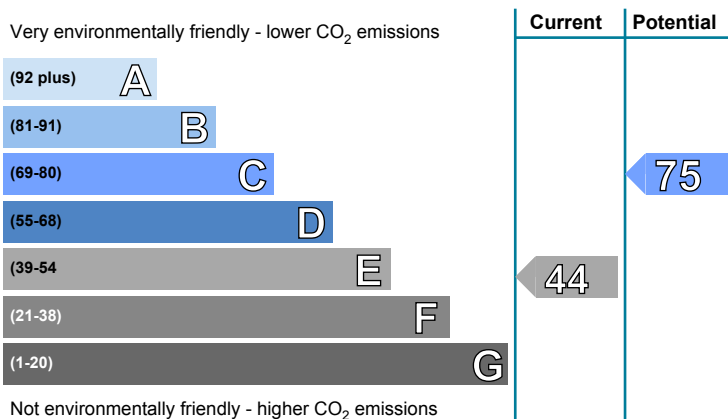
Environmental Impact (CO₂) Rating

This graph shows the effect of your home on the environment in terms of carbon dioxide (CO₂) emissions. The higher the rating, the less impact it has on the environment.
