Home Report

Scottish Single Survey

Single Survey

Property address	39 Merkland Drive Kirkintilloch Glasgow G66 3SD
Customer	JINGYI YANG
Customer address	39 Merkland Drive Kirkintilloch Glasgow G66 3SD
Prepared by	Shepherd Chartered Surveyors
Date of inspection	02/10/2024

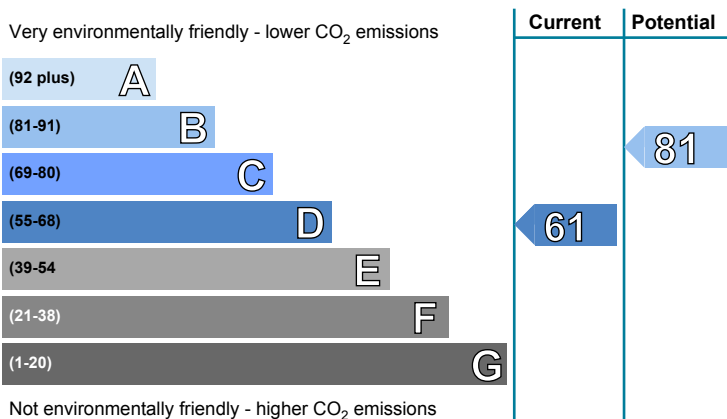
Environmental Impact (CO₂) Rating

This graph shows the effect of your home on the environment in terms of carbon dioxide (CO₂) emissions. The higher the rating, the less impact it has on the environment.
