Scottish Single Survey

Single Survey

Property address	2/2 10 Heathcot Place Glasgow G15 8NZ
Customer	Anahita Parandian
Customer address	2/2 10 Heathcot Place Glasgow G15 8NZ
Prepared by	Shepherd Chartered Surveyors
Date of inspection	21/10/2024

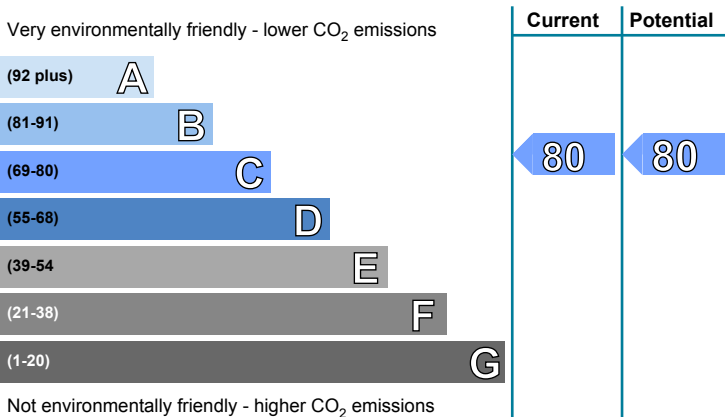
Environmental Impact (CO₂) Rating

This graph shows the effect of your home on the environment in terms of carbon dioxide (CO₂) emissions. The higher the rating, the less impact it has on the environment.
