Home Report

Single Survey

Property address	5 Woodhead Terrace Chryston Glasgow G69 9BP
Customer	Mr Martin McLaughlin
Customer address	5 Woodhead Terrace Chryston Glasgow G69 9BP
Prepared by	Shepherd Chartered Surveyors
Date of inspection	18/10/2024

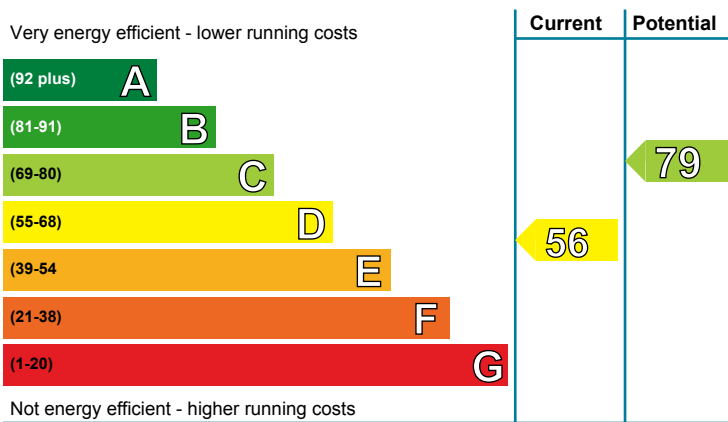
Energy Efficiency Rating

This graph shows the current efficiency of your home, taking into account both energy efficiency and fuel costs. The higher this rating, the lower your fuel bills are likely to be.

Your current rating is **band D (56)**. The average rating for EPCs in Scotland is **band D (61)**.

The potential rating shows the effect of undertaking all of the improvement measures listed within your recommendations report.
