**HOME**  
report

SINGLE SURVEY  
ENERGY REPORT  
PROPERTY QUESTIONNAIRE  
VALUATION REPORT

# Single Survey

| <b>Property Address</b> | 19 Cockburn Avenue Dunblane FK15 0FP |

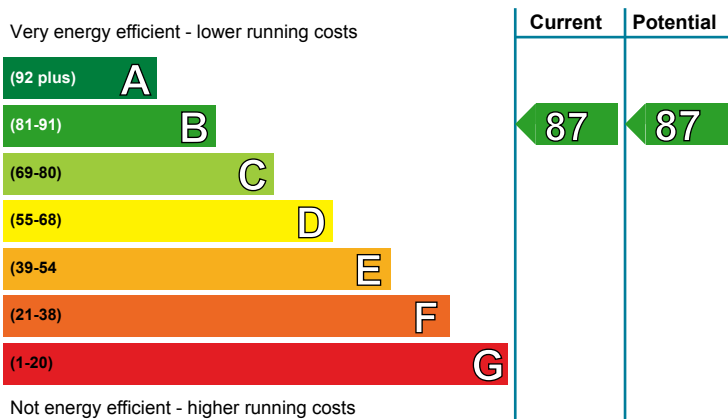
## Energy Efficiency Rating

This graph shows the current efficiency of your home, taking into account both energy efficiency and fuel costs. The higher this rating, the lower your fuel bills are likely to be.

Your current rating is **band B (87)**. The average rating for EPCs in Scotland is **band D (61)**.

The potential rating shows the effect of undertaking all of the improvement measures listed within your recommendations report.

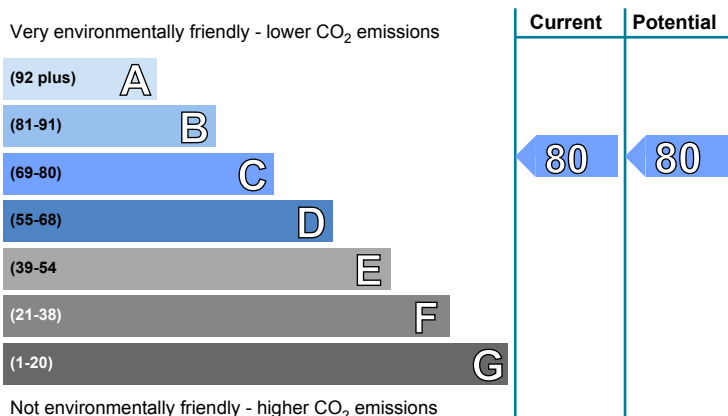
## Environmental Impact (CO<sub>2</sub>) Rating

This graph shows the effect of your home on the environment in terms of carbon dioxide (CO<sub>2</sub>) emissions. The higher the rating, the less impact it has on the environment.
