Home Report

Single Survey

Property address	1 Holmehill Court Dunblane FK15 0AF
Customer	Mr James Lind
Customer address	
Prepared by	Shepherd Chartered Surveyors
Date of inspection	15/01/2026

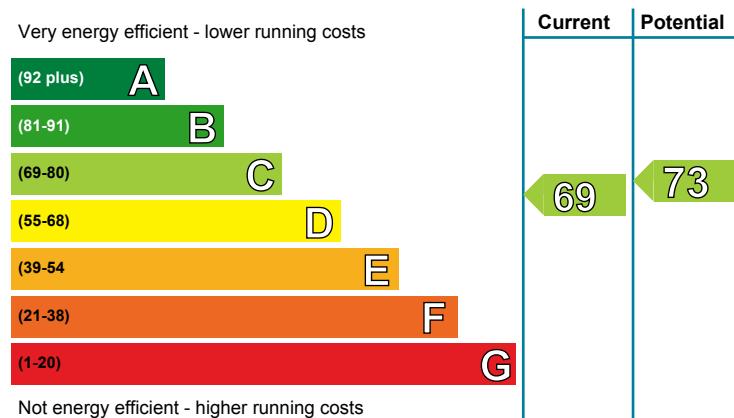
Energy Efficiency Rating

This graph shows the current efficiency of your home, taking into account both energy efficiency and fuel costs. The higher this rating, the lower your fuel bills are likely to be.

Your current rating is **band C (69)**. The average rating for EPCs in Scotland is **band D (61)**.

The potential rating shows the effect of undertaking all of the improvement measures listed within your recommendations report.

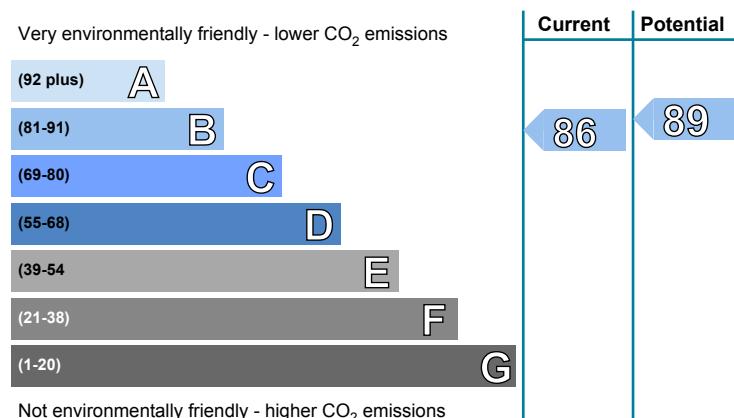
Environmental Impact (CO₂) Rating

This graph shows the effect of your home on the environment in terms of carbon dioxide (CO₂) emissions. The higher the rating, the less impact it has on the environment.
