- 1. Scottish Single Survey
- 2. Energy Performance Certificate
- 3. Property Questionnaire

# Scottish Single Survey

Property address	5 Ailsa Road Bishopbriggs Glasgow G64 1EA
------------------	--

Date of inspection	17/06/2024

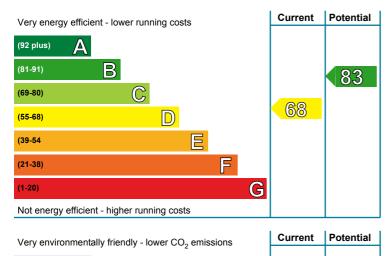
Estimated energy costs for your home for 3 years*	£4,296	See your recommendations	
Over 3 years you could save*	£579	report for more information

\* based upon the cost of energy for heating, hot water, lighting and ventilation, calculated using standard assumptions
