4 MYRTLE SQUARE BISHOPBRIGGS GLASGOW G64 1LX

Energy Performance Certificate (EPC)

Dwelling type: Mid-terrace house
Date of assessment: 19 November 2024
Date of certificate: 19 November 2024

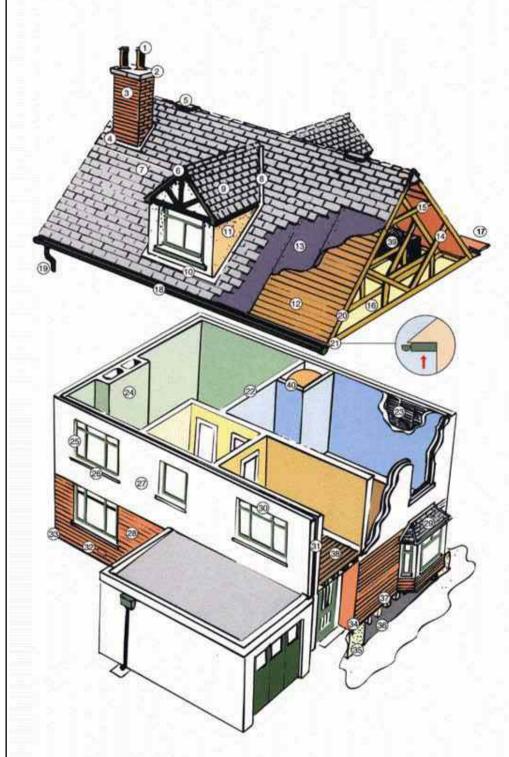
Sectional Diagram showing elements of a typical house

Reference may be made in this report to some or all of the above component parts of the property. This diagram may assist you in locating and understanding these items.

- 1) Chimney pots
- 2) Coping stone
- 3) Chimney head
- 4) Flashing
- (5) Ridge ventilation
- 6) Ridge board
- 7) Slates / tiles
- 8 Valley guttering
- 9) Dormer projection
- (10) Dormer flashing
- 11) Dormer cheeks
- 12) Sarking
- 13) Roof felt
- (14) Trusses
- 15) Collar
- (16) Insulation
- 7) Parapet gutter
- 18) Eaves guttering
- 19) Rainwater downpipe
- Verge boards /skews
- 21) Soffit boards
- 22) Partition wall
- 23) Lath / plaster
- co Latir/ plaster
- Chimney breast
- 25) Window pointing
- 26) Window sills
- (27) Rendering
- 28) Brickwork / pointing
- (29) Bay window projection
- (30) Lintels
- (31) Cavity walls / wall ties
- 32) Subfloor ventilator
- 33) Damp proof course
- 34) Base course
- 35) Foundations
- 36) Solum
- 37 Floor joists
- 38) Floorboards
- 9) Water tank
- 10) Hot water tank
