Home Report

Scottish Single Survey

Single Survey

Property address	47 Campbell Street Helensburgh G84 9QW
-------------------------	--

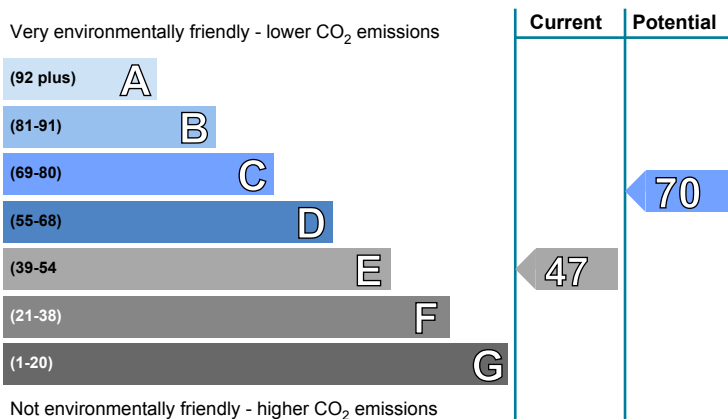
Environmental Impact (CO₂) Rating

This graph shows the effect of your home on the environment in terms of carbon dioxide (CO₂) emissions. The higher the rating, the less impact it has on the environment.
