Home Report

Scottish
Single Survey

Property address	78 Feorlin Way Garelochhead Helensburgh G84 0DX
Customer	Kirstie Ess
Customer address	78 Feorlin Way Garelochhead Helensburgh G84 0DX
Prepared by	Shepherd Chartered Surveyors
Date of inspection	24/07/2025

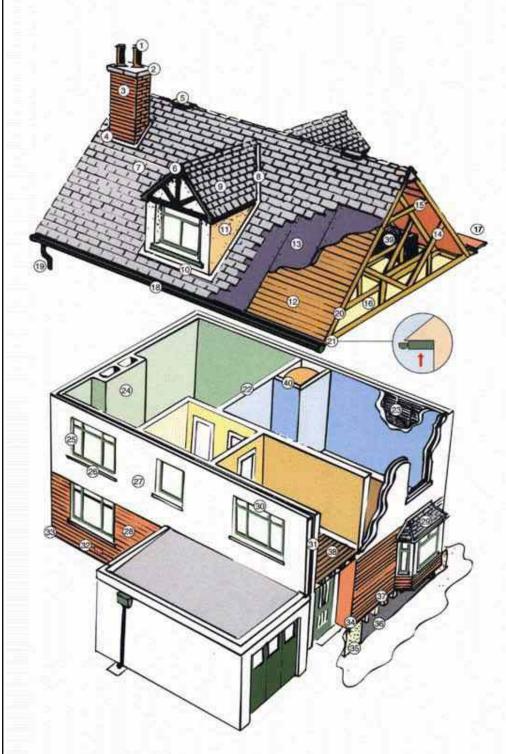
Sectional Diagram showing elements of a typical house

Reference may be made in this report to some or all of the above component parts of the property. This diagram may assist you in locating and understanding these items.

- (1) Chimney pots
- 2) Coping stone
- (3) Chimney head
- (4) Flashing
- 5) Ridge ventilation
- (6) Ridge board
- (7) Slates / tiles
- 8 Valley guttering
- 9 Dormer projection
- 10 Dormer flashing
- 11) Dormer cheeks
- (12) Sarking
- 13) Roof felt
- (14) Trusses
- (15) Collar
- 16) Insulation
- 17) Parapet gutter
- 18) Eaves guttering
- 19 Rainwater downpipe
- 20) Verge boards/skews
- 21) Soffit boards
- 22) Partition wall
- 23) Lath / plaster
- (24) Chimney breast
- 25) Window pointing
- Window sills
- 27) Rendering
- (28) Brickwork / pointing
- 29) Bay window projection
- (30) Lintels
- (31) Cavity walls / wall ties
- 32) Subfloor ventilator
- (33) Damp proof course
- (34) Base course
- 35) Foundations
- 36) Solum
- 37) Floor joists
- 8) Floorboards
- 39) Water tank
- (40) Hot water tank
