Home Report

121 Dalrymple Street
Girvan
KA26 9BS

single survey

survey report on:

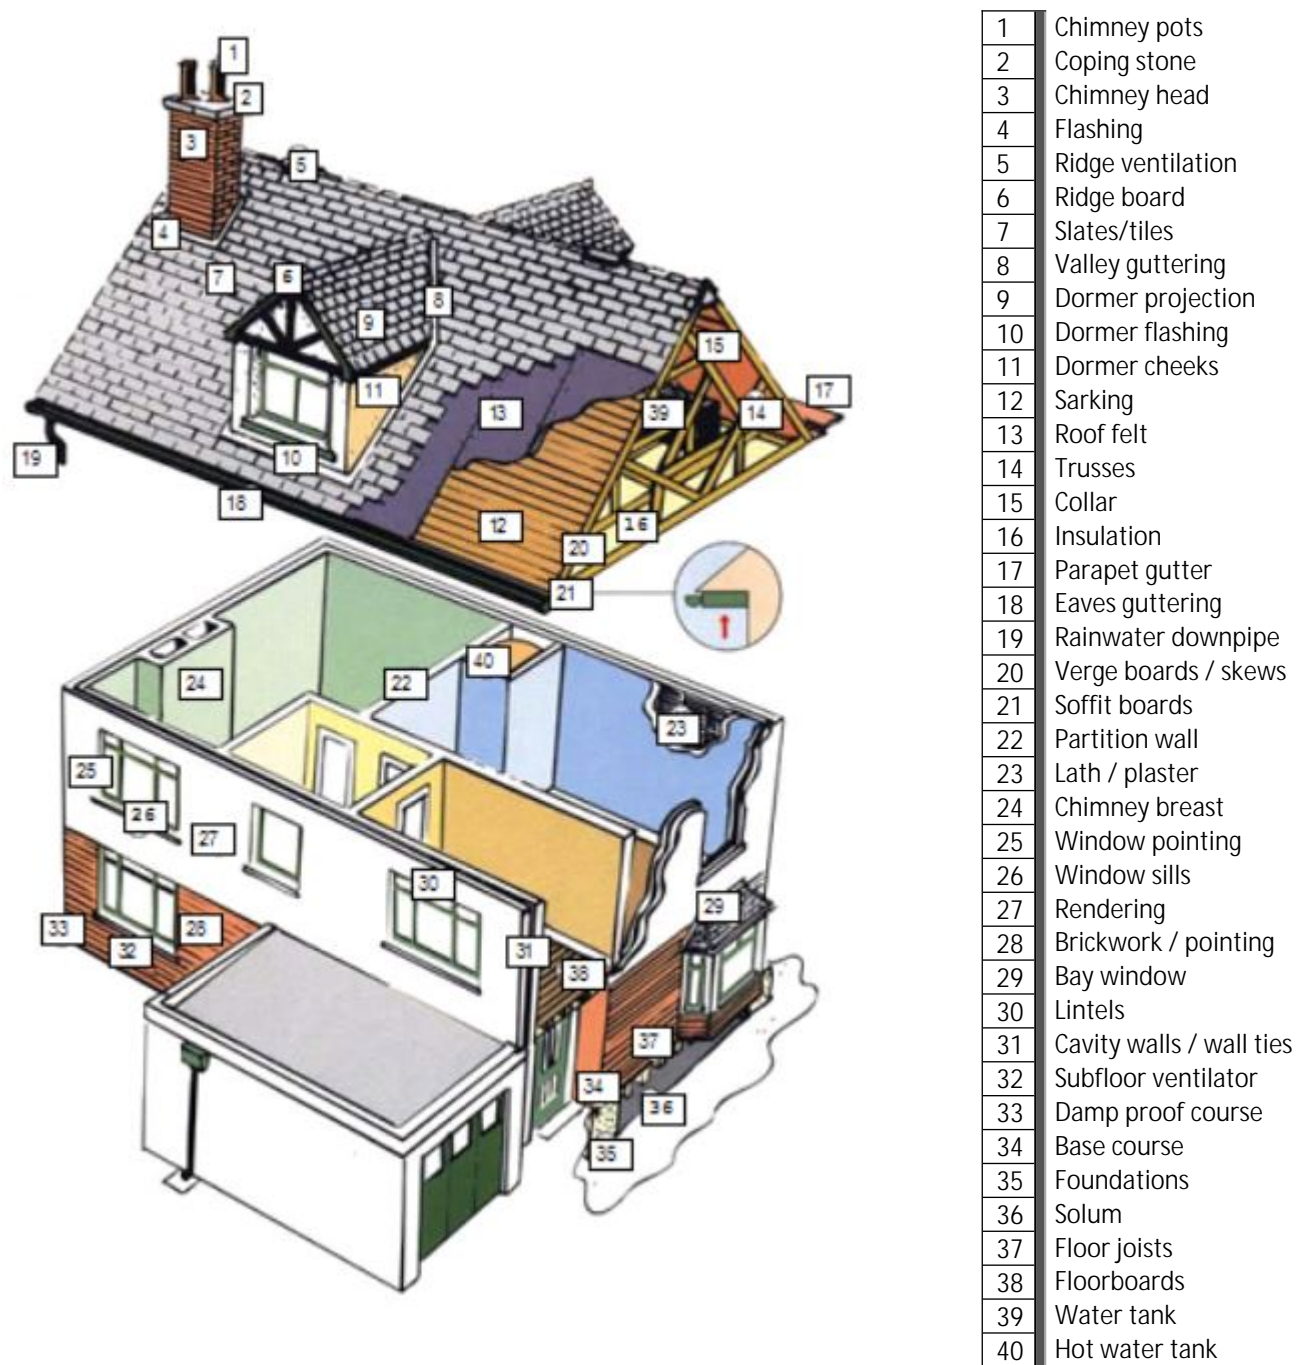
Sectional Diagram showing elements of a typical house

Reference may be made in this report to some or all of the above component parts of the property. This diagram may assist you in locating and understanding these items.
