Home Report

1 Bridgend Cottages
Dunreggan
Moniaive
Thornhill
DG3 4HQ

single survey

Property address	1 Bridgend Cottages Dunreggan Moniaive Thornhill DG3 4HQ
Customer	Andrew Wilson
Prepared by	Graham + Sibbald LLP

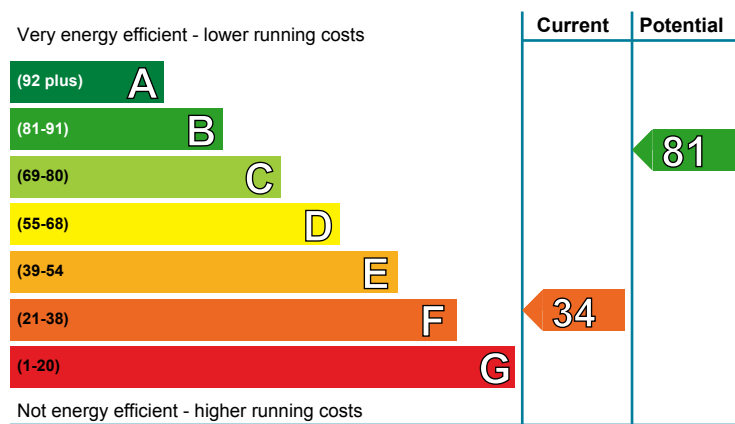
Energy Efficiency Rating

This graph shows the current efficiency of your home, taking into account both energy efficiency and fuel costs. The higher this rating, the lower your fuel bills are likely to be.

Your current rating is **band F (34)**. The average rating for EPCs in Scotland is **band D (61)**.

The potential rating shows the effect of undertaking all of the improvement measures listed within your recommendations report.
