4 SOMERVILLE ROAD
CURRIEHILL
BALERNO
EH14 5BF

Home Report

4 SOMERVILLE ROAD, CURRIEHILL, BALERNO, EH14 5BF

Dwelling type: Detached house
Date of assessment: 15 February 2024
Date of certificate: 28 February 2024
Total floor area: 128 m²
Primary Energy Indicator: 103 kWh/m²/year

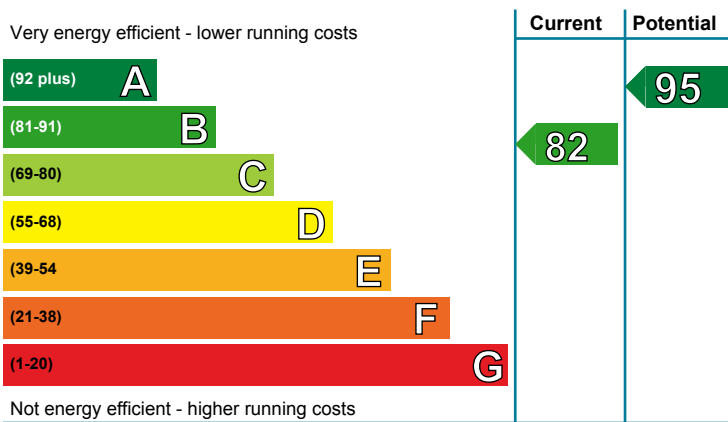
Energy Efficiency Rating

This graph shows the current efficiency of your home, taking into account both energy efficiency and fuel costs. The higher this rating, the lower your fuel bills are likely to be.

Your current rating is **band B (82)**. The average rating for EPCs in Scotland is **band D (61)**.

The potential rating shows the effect of undertaking all of the improvement measures listed within your recommendations report.
