## SINGLE SURVEY REPORT

FLAT 6  
3 BOWHILL TERRACE  
EDINBURGH  
EH3 5QY

INSPECTION DATE:

21<sup>ST</sup> MAY 2024

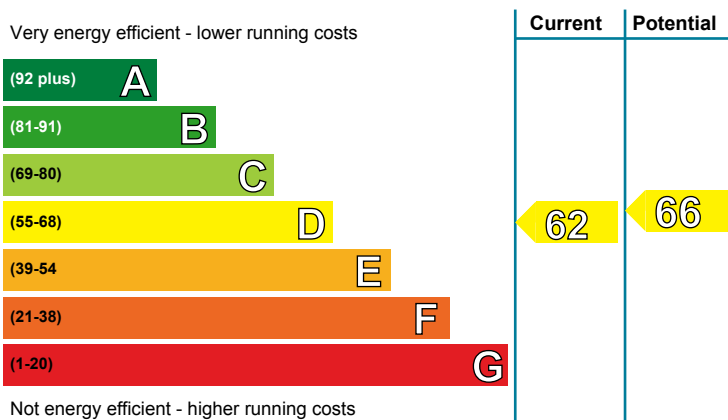
## Energy Efficiency Rating

This graph shows the current efficiency of your home, taking into account both energy efficiency and fuel costs. The higher this rating, the lower your fuel bills are likely to be.

Your current rating is **band D (62)**. The average rating for EPCs in Scotland is **band D (61)**.

The potential rating shows the effect of undertaking all of the improvement measures listed within your recommendations report.

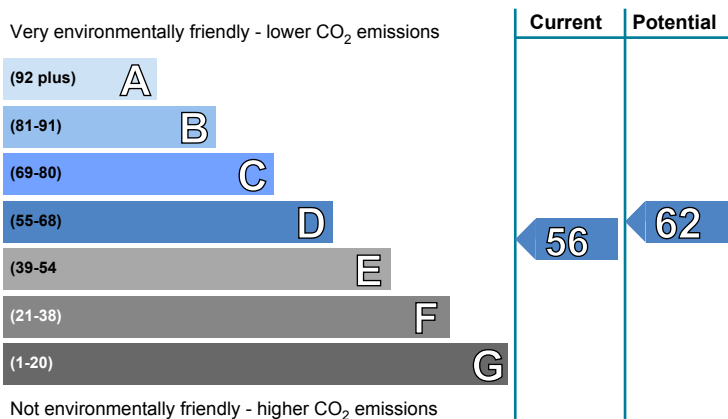
## Environmental Impact (CO<sub>2</sub>) Rating

This graph shows the effect of your home on the environment in terms of carbon dioxide (CO<sub>2</sub>) emissions. The higher the rating, the less impact it has on the environment.
