SINGLE SURVEY REPORT

**49 CLACKMAE ROAD
EDINBURGH
EH16 6NY**

19TH SEPTEMBER 2024

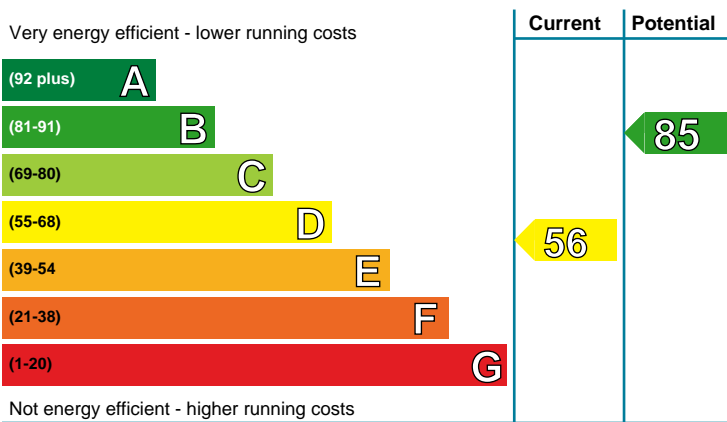
Energy Efficiency Rating

This graph shows the current efficiency of your home, taking into account both energy efficiency and fuel costs. The higher this rating, the lower your fuel bills are likely to be.

Your current rating is **band D (56)**. The average rating for EPCs in Scotland is **band D (61)**.

The potential rating shows the effect of undertaking all of the improvement measures listed within your recommendations report.
