# Home Report

# Single Survey

46 Kylemore Crescent,  
Motherwell,  
Lanarkshire,  
ML1 3XP

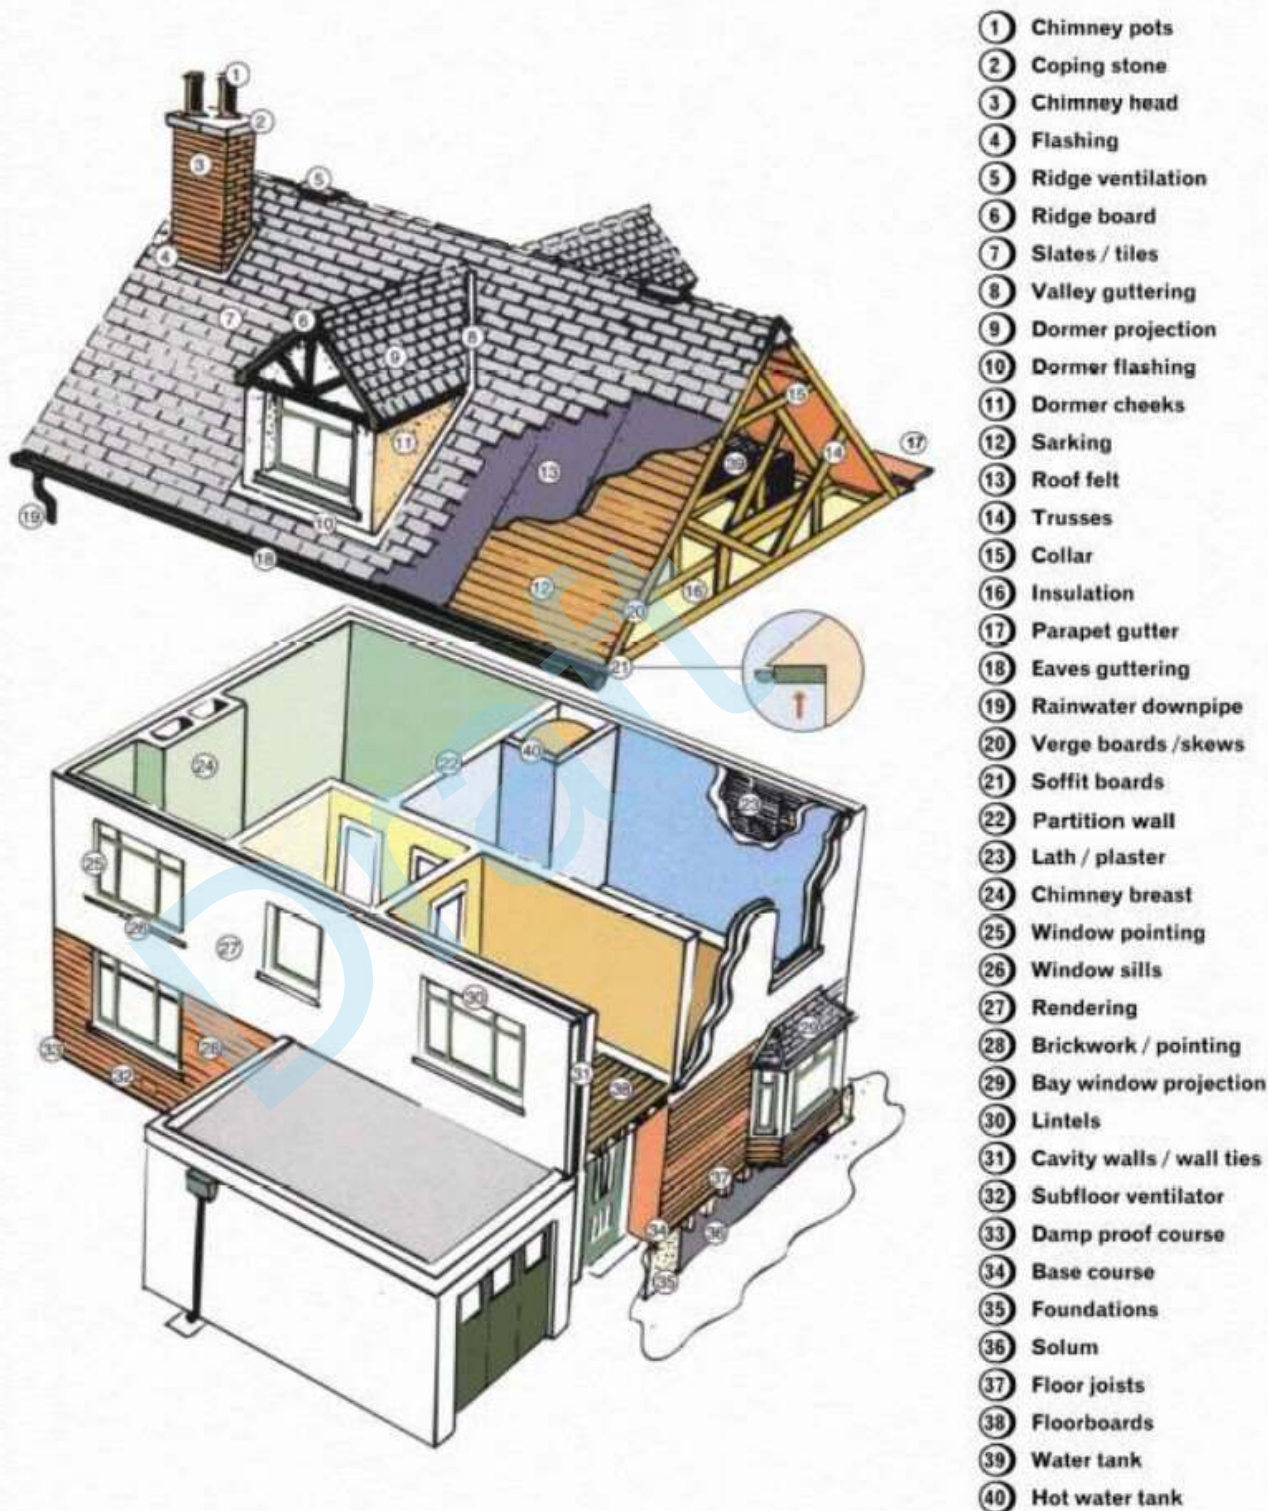
## Sectional Diagram showing elements of a typical house

Reference may be made in this report to some or all of the above component parts of the property. This diagram may assist you in locating and understanding these items.
