YOUR ONESURVEY  
**HOME REPORT**

15 Lundavra Crescent  
Fort William  
PH33 6JL

# SINGLE SURVEY

A report on the condition of the property, with categories being rated from 1 to 3.

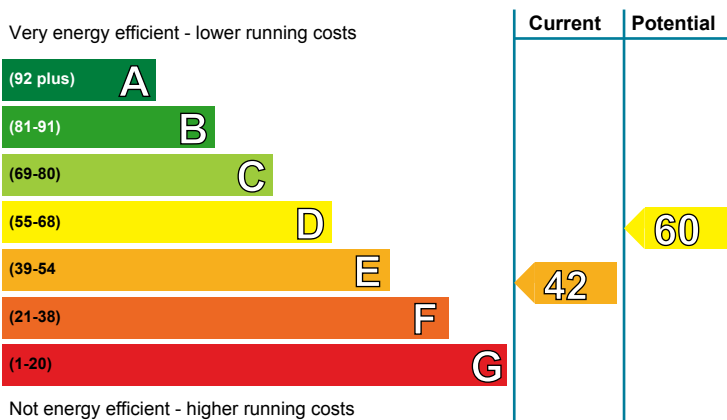
## Energy Efficiency Rating

This graph shows the current efficiency of your home, taking into account both energy efficiency and fuel costs. The higher this rating, the lower your fuel bills are likely to be.

Your current rating is **band E (42)**. The average rating for EPCs in Scotland is **band D (61)**.

The potential rating shows the effect of undertaking all of the improvement measures listed within your recommendations report.

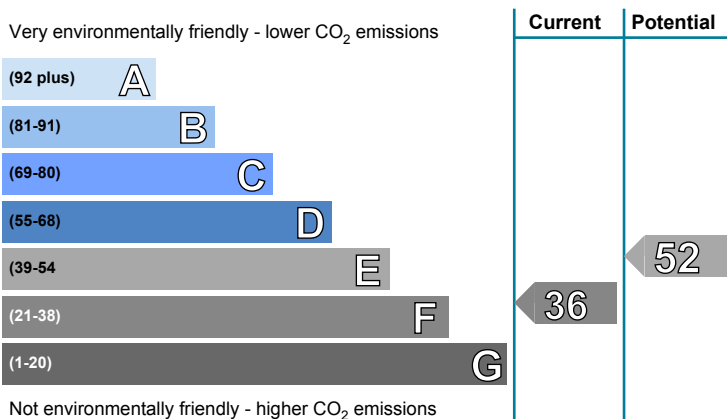
## Environmental Impact (CO<sub>2</sub>) Rating

This graph shows the effect of your home on the environment in terms of carbon dioxide (CO<sub>2</sub>) emissions. The higher the rating, the less impact it has on the environment.
