YOUR ONESURVEY
HOME REPORT

30 Lyle Road
Airdrie
ML6 8NB

SINGLE SURVEY

Single Survey

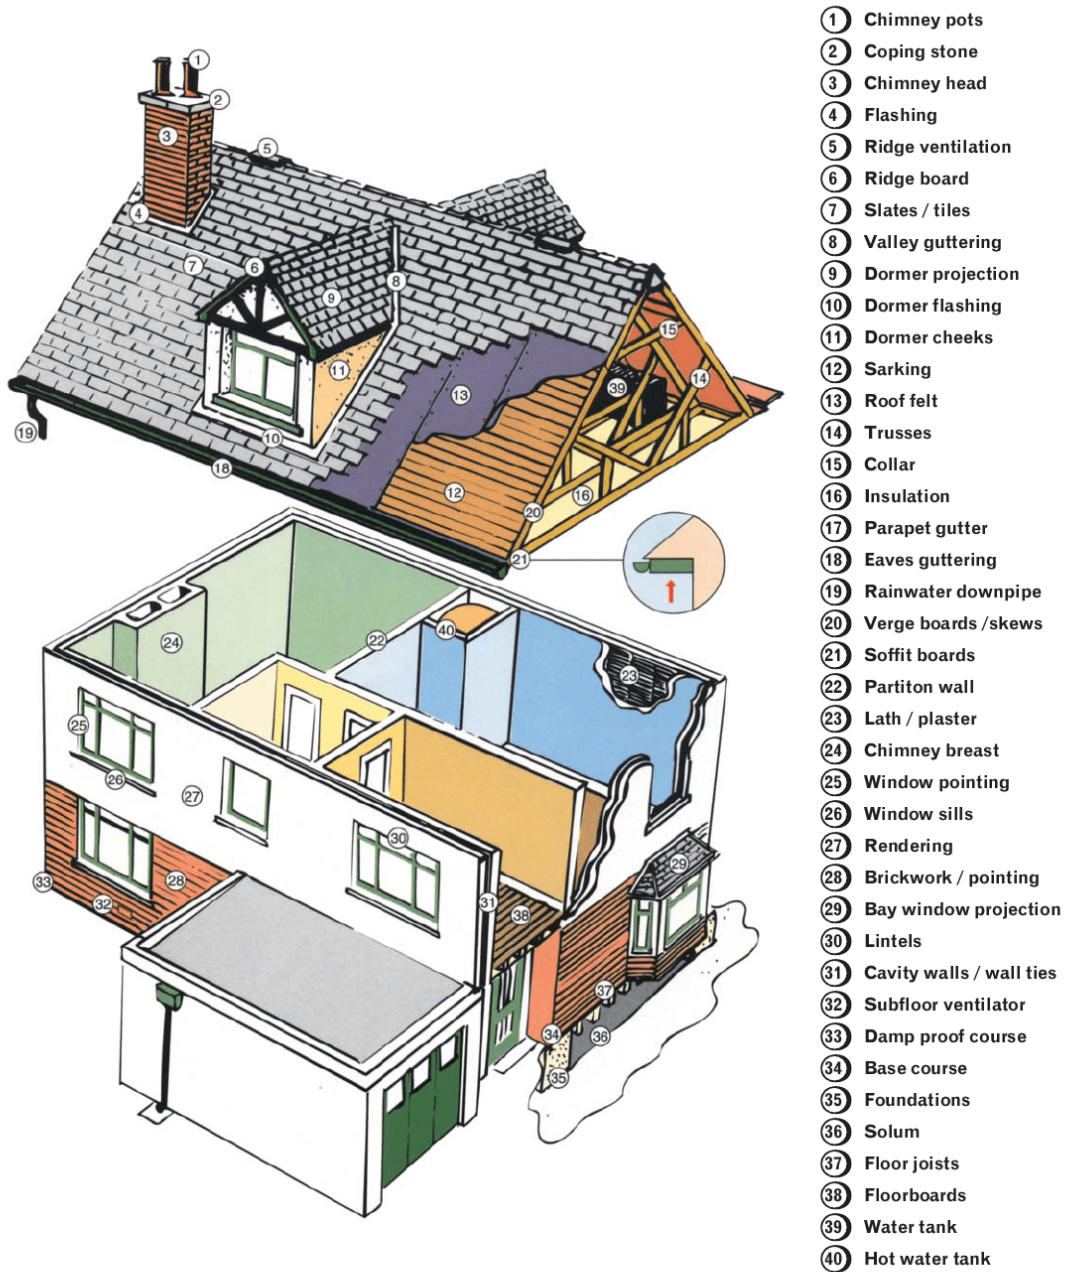
Sectional Diagram showing elements of a typical house

Reference may be made in this report to some or all of the above component parts of the property. This diagram may assist you in locating and understanding these items.

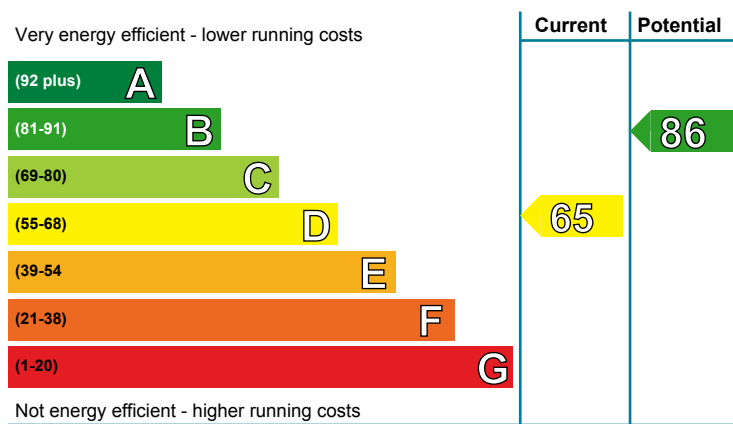
Energy Efficiency Rating

This graph shows the current efficiency of your home, taking into account both energy efficiency and fuel costs. The higher this rating, the lower your fuel bills are likely to be.

Your current rating is **band D (65)**. The average rating for EPCs in Scotland is **band D (61)**.

The potential rating shows the effect of undertaking all of the improvement measures listed within your recommendations report.

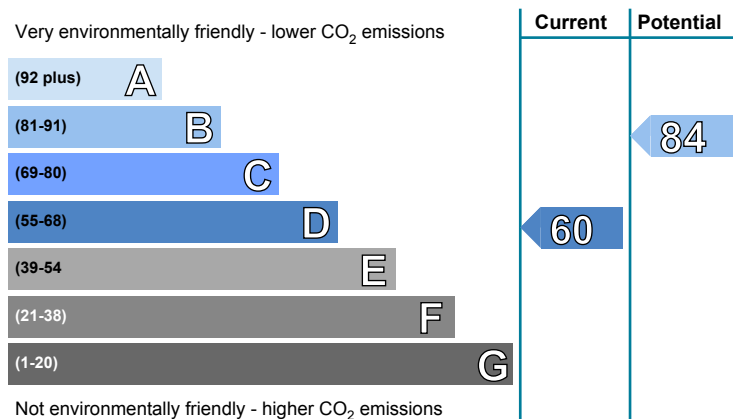
Environmental Impact (CO₂) Rating

This graph shows the effect of your home on the environment in terms of carbon dioxide (CO₂) emissions. The higher the rating, the less impact it has on the environment.
