YOUR ONESURVEY HOME REPORT

5 Tweed Court Airdrie ML6 9QJ

Single Survey

Date of Inspection	20/05/2024
Prepared by	Donald Watt, BSc MRICS
	Hamilton - Allied Surveyors Scotland Ltd

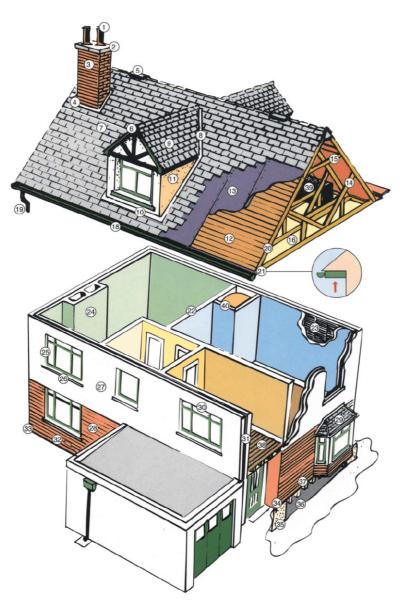
Sectional Diagram showing elements of a typical house

Reference may be made in this report to some or all of the above component parts of the property. This diagram may assist you in locating and understanding these items. (1) Chimney pots Coping stone 2 Chimney head 3 4 Flashing 5 **Ridge ventilation** 6 Ridge board (7) Slates / tiles 8 Valley guttering **9** Dormer projection **Dormer flashing Dormer cheeks** (12) Sarking (13) Roof felt (14) Trusses (15) Collar 16 Insulation 17 Parapet gutter (18) Eaves guttering (19) Rainwater downpipe (20) Verge boards / skews (21) Soffit boards 22 Partiton wall 23 Lath / plaster (24) Chimney breast (25) Window pointing (26) Window sills (27) Rendering (28) Brickwork / pointing (29) Bay window projection 30 Lintels (31) Cavity walls / wall ties 32 Subfloor ventilator 33 Damp proof course (34) Base course **35** Foundations 36 Solum (37) Floor joists
