YOUR ONESURVEY HOME REPORT

59 Staffa Drive Airdrie ML6 8NG

Single Survey

Prepared by	Donald Watt, BSc MRICS
	Hamilton - Allied Surveyors Scotland Ltd

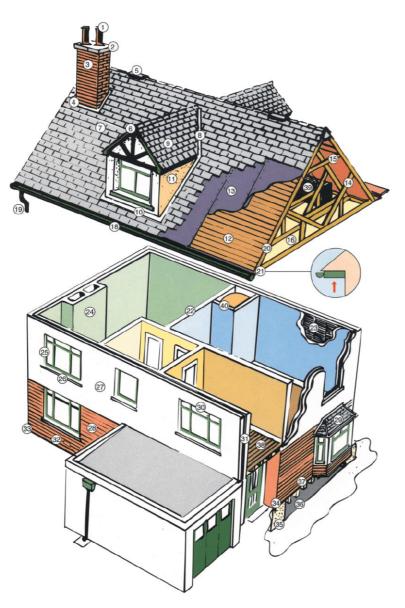
Sectional Diagram showing elements of a typical house

Reference may be made in this report to some or all of the above component parts of the property. This diagram may assist you in locating and understanding these items.
