YOUR ONESURVEY HOME REPORT

16 Craigneuk Avenue Airdrie ML6 8AW

Single Survey

Date of Inspection	16/09/2024
Prepared by	Donald Watt, BSc MRICS

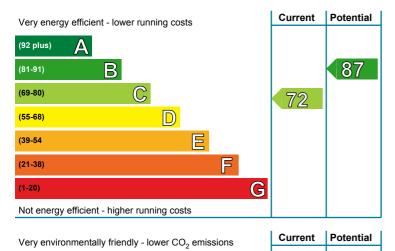
Energy Efficiency Rating

This graph shows the current efficiency of your home, taking into account both energy efficiency and fuel costs. The higher this rating, the lower your fuel bills are likely to be.
