- 1. Single Survey
- 2. Energy Report
- 3. Property Questionnaire

Survey report on:

Property Address	19 Wellesley Drive, Cumbernauld, Glasgow, G68 9PG
Customer	Mr M Campbell
Date of Inspection	26/09/2024
Prepared by	Duncan Somerville Harvey Donaldson & Gibson Chartered Surveyors

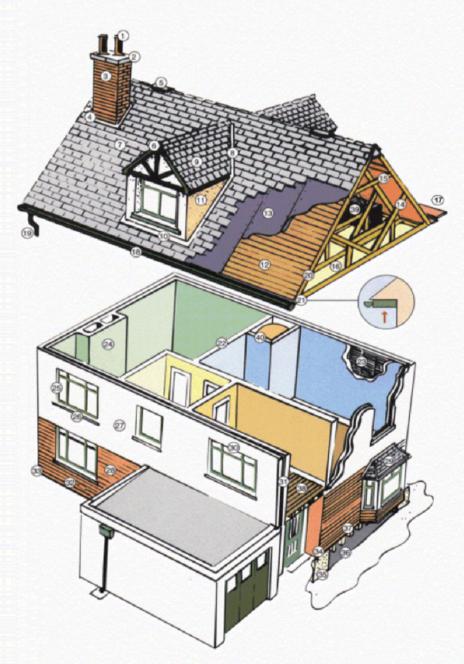
Sectional Diagram showing elements of a typical house

Reference may be made in this report to some or all of the above component parts of the property. This diagram may assist you in locating and understanding these items.

- **Chimney pots**
- Coping stone
- Chimney head
- Flashing
- Ridge ventilation
- 6 Ridge board
- 7 Slates / tiles
- 8 Valley guttering
- 9 Dormer projection
- 10 Dormer flashing
- (11) **Dormer cheeks**
- 12 Sarking
- 13) Roof felt
- (14) Trusses
- (15) Collar
- 16 Insulation
- 17) Parapet gutter
- (18) Eaves guttering
- Rainwater downpipe
- 20 Verge boards /skews
- (21) Soffit boards
- 22) Partition wall
- 23 Lath / plaster
- 24) Chimney breast
- 25) Window pointing
- (26) Window sills
- (27) Rendering
- Brickwork / pointing
- 29 Bay window projection
- (30) Lintels
- 31) Cavity walls / wall ties
- 32) Subfloor ventilator
- 33 Damp proof course
- 34) Base course
- 35) Foundations
- (36) Solum
- 37) Floor joists
- 38) Floorboards
- 39 Water tank
- (40) Hot water tank
