YOUR ONESURVEY HOME REPORT

35 Moffat View Plains, Airdrie ML6 7LN

Single Survey

Date of Inspection	03/10/2024
Prepared by	Donald Watt, BSc MRICS

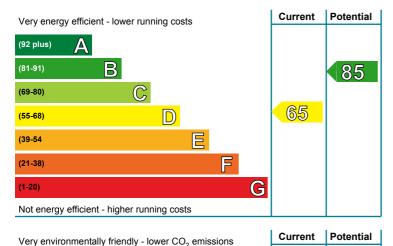
Energy Efficiency Rating

This graph shows the current efficiency of your home, taking into account both energy efficiency and fuel costs. The higher this rating, the lower your fuel bills are likely to be.
