Home Report

Single Survey

| Property address | 39 Brandon Way Coatbridge ML5 5QT |
| Prepared by | Shepherd Chartered Surveyors |

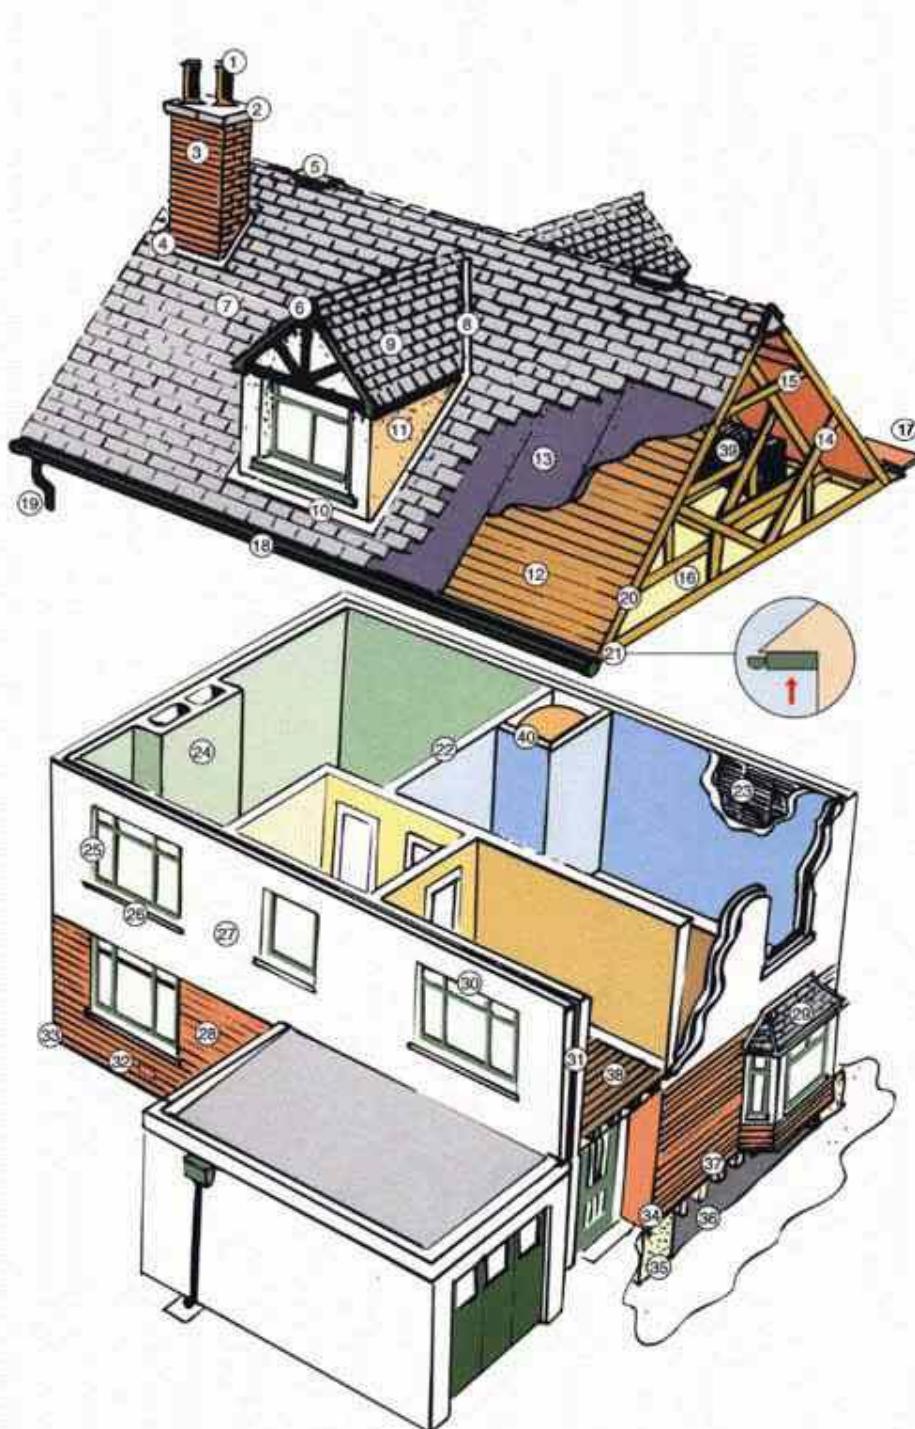
Sectional Diagram showing elements of a typical house

- 1 Chimney pots
- 2 Coping stone
- 3 Chimney head
- 4 Flashing
- 5 Ridge ventilation
- 6 Ridge board
- 7 Slates / tiles
- 8 Valley guttering
- 9 Dormer projection
- 10 Dormer flashing
- 11 Dormer cheeks
- 12 Sarking
- 13 Roof felt
- 14 Trusses
- 15 Collar
- 16 Insulation
- 17 Parapet gutter
- 18 Eaves guttering
- 19 Rainwater downpipe
- 20 Verge boards /skews
- 21 Soffit boards
- 22 Partition wall
- 23 Lath / plaster
- 24 Chimney breast
- 25 Window pointing
- 26 Window sills
- 27 Rendering
- 28 Brickwork / pointing
- 29 Bay window projection
- 30 Lintels
- 31 Cavity walls / wall ties
- 32 Subfloor ventilator
- 33 Damp proof course
- 34 Base course
- 35 Foundations
- 36 Solum
- 37 Floor joists
- 38 Floorboards
- 39 Water tank
- 40 Hot water tank

Reference may be made in this report to some or all of the above component parts of the property. This diagram may assist you in locating and understanding these items.
