HOME
report

SINGLE SURVEY
ENERGY REPORT
PROPERTY QUESTIONNAIRE
VALUATION REPORT

Property address	2 Castle Street, Tain, IV19 1AH
-------------------------	---------------------------------------

Date of inspection	4th January 2018
---------------------------	------------------

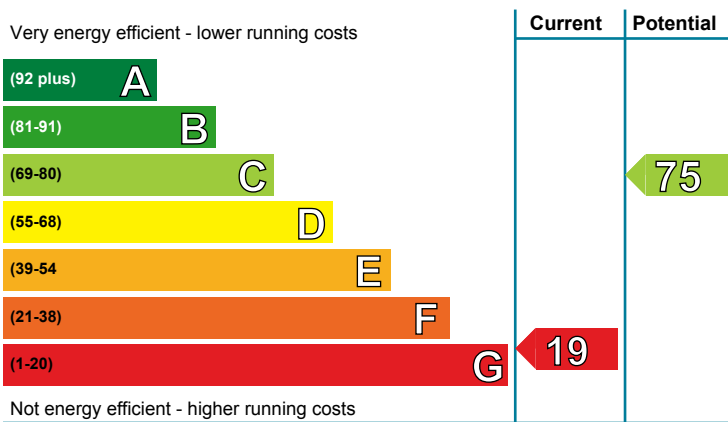
Energy Efficiency Rating

This graph shows the current efficiency of your home, taking into account both energy efficiency and fuel costs. The higher this rating, the lower your fuel bills are likely to be.

Your current rating is **band G (19)**. The average rating for EPCs in Scotland is **band D (61)**.

The potential rating shows the effect of undertaking all of the improvement measures listed within your recommendations report.
