HOME REPORT

BACK COTTAGE THE SQUARE ACHNABA SQUARE

ENERGY PERFORMANCE CERTIFICATE

SINGLE SURVEY

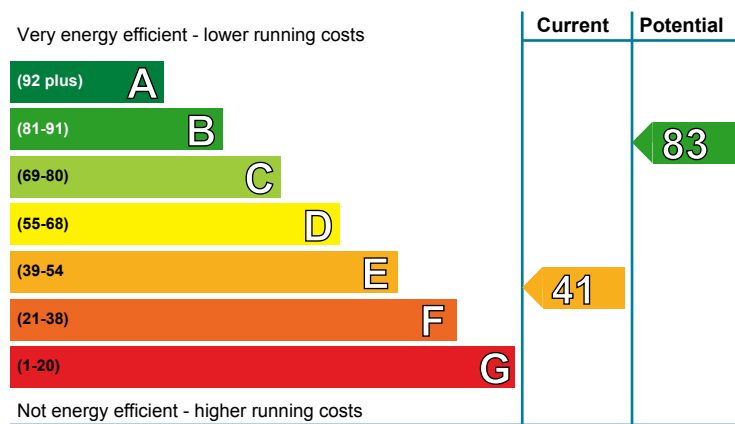
Energy Efficiency Rating

This graph shows the current efficiency of your home, taking into account both energy efficiency and fuel costs. The higher this rating, the lower your fuel bills are likely to be.

Your current rating is **band E (41)**. The average rating for EPCs in Scotland is **band D (61)**.

The potential rating shows the effect of undertaking all of the improvement measures listed within your recommendations report.

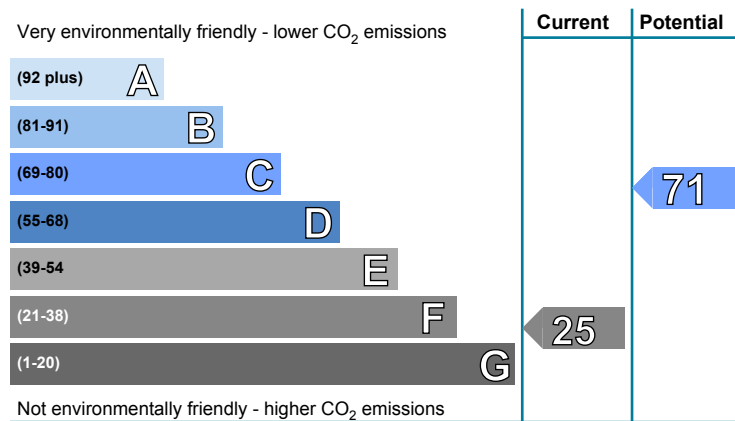
Environmental Impact (CO₂) Rating

This graph shows the effect of your home on the environment in terms of carbon dioxide (CO₂) emissions. The higher the rating, the less impact it has on the environment.

Your current rating is **band F (25)**. The average rating for EPCs in Scotland is **band D (59)**.

The potential rating shows the effect of undertaking all of the improvement measures listed within your recommendations report.
