HOME REPORT

KINABUS CLACHAN

TARBERT
PA29 6XL

Energy Performance Certificate (EPC)

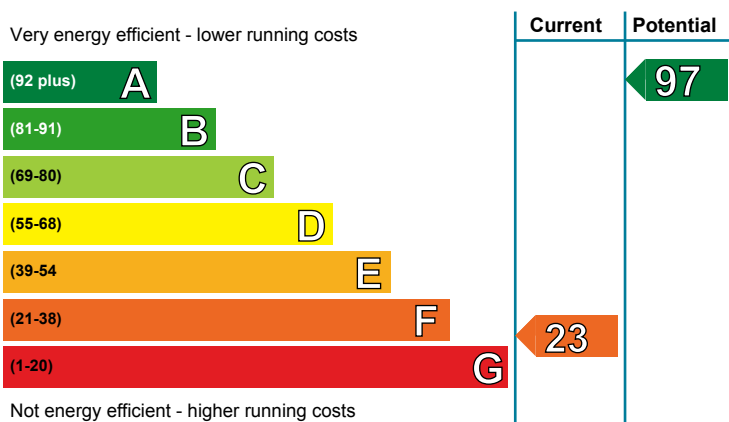
Energy Efficiency Rating

This graph shows the current efficiency of your home, taking into account both energy efficiency and fuel costs. The higher this rating, the lower your fuel bills are likely to be.

Your current rating is **band F (23)**. The average rating for EPCs in Scotland is **band D (61)**.

The potential rating shows the effect of undertaking all of the improvement measures listed within your recommendations report.

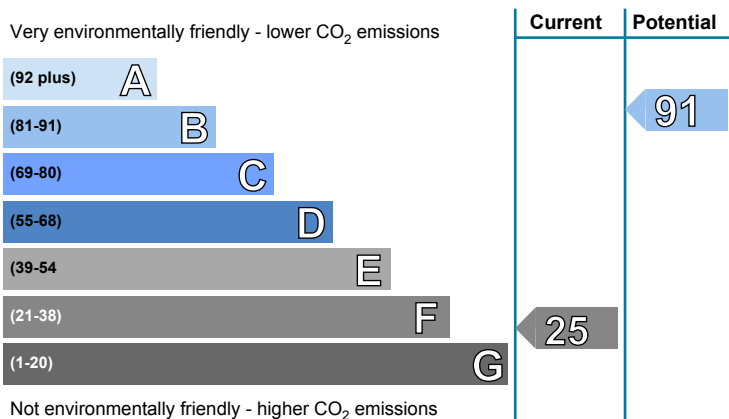
Environmental Impact (CO₂) Rating

This graph shows the effect of your home on the environment in terms of carbon dioxide (CO₂) emissions. The higher the rating, the less impact it has on the environment.

Your current rating is **band F (25)**. The average rating for EPCs in Scotland is **band D (59)**.

The potential rating shows the effect of undertaking all of the improvement measures listed within your recommendations report.
