HOME REPORT

GRULIN MOR GRUINART

ISLE OF ISLAY
PA44 7PS

Energy Performance Certificate (EPC)

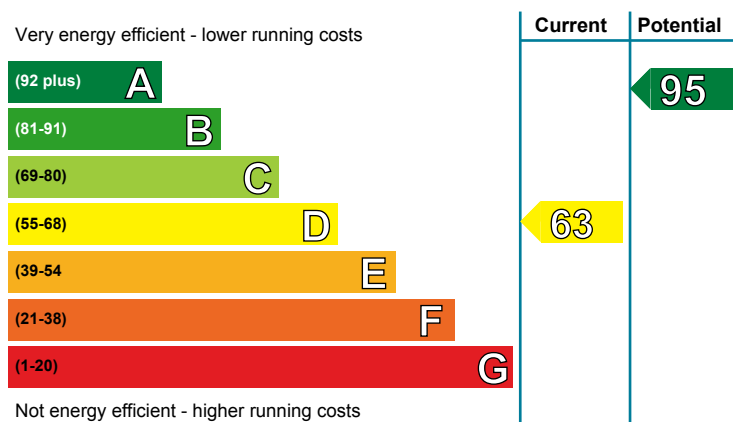
Energy Efficiency Rating

This graph shows the current efficiency of your home, taking into account both energy efficiency and fuel costs. The higher this rating, the lower your fuel bills are likely to be.

Your current rating is **band D (63)**. The average rating for EPCs in Scotland is **band D (61)**.

The potential rating shows the effect of undertaking all of the improvement measures listed within your recommendations report.

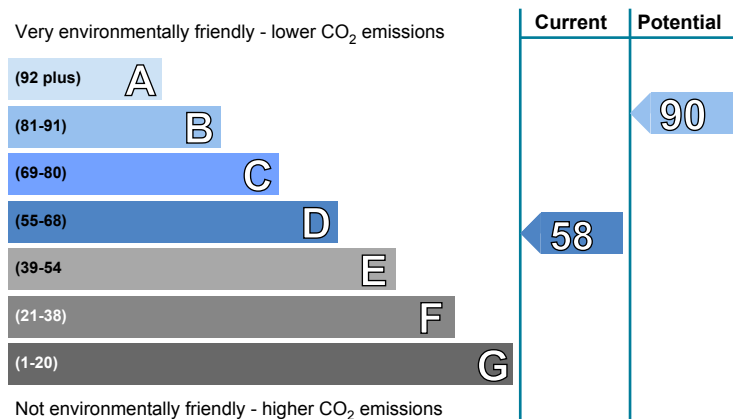
Environmental Impact (CO₂) Rating

This graph shows the effect of your home on the environment in terms of carbon dioxide (CO₂) emissions. The higher the rating, the less impact it has on the environment.

Your current rating is **band D (58)**. The average rating for EPCs in Scotland is **band D (59)**.

The potential rating shows the effect of undertaking all of the improvement measures listed within your recommendations report.
