HOME REPORT

SMITHY HOUSE BRIDGEND

ISLE OF ISLAY
PA44 7PG

Single Survey

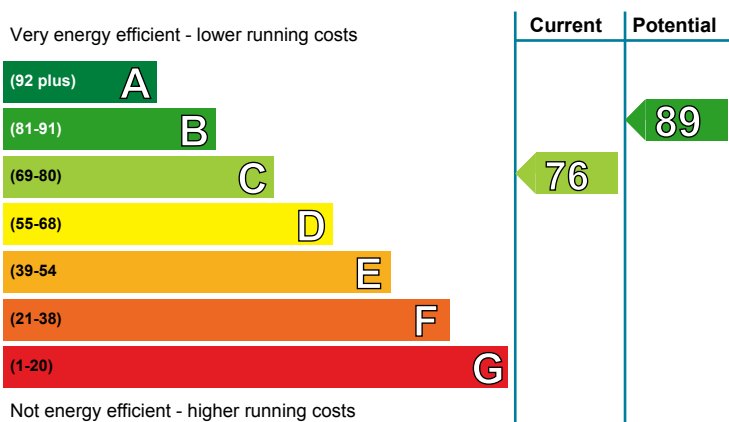
Energy Efficiency Rating

This graph shows the current efficiency of your home, taking into account both energy efficiency and fuel costs. The higher this rating, the lower your fuel bills are likely to be.

Your current rating is **band C (76)**. The average rating for EPCs in Scotland is **band D (61)**.

The potential rating shows the effect of undertaking all of the improvement measures listed within your recommendations report.

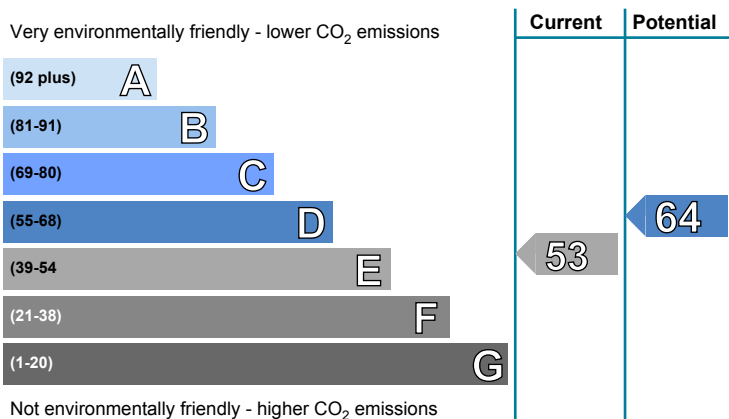
Environmental Impact (CO₂) Rating

This graph shows the effect of your home on the environment in terms of carbon dioxide (CO₂) emissions. The higher the rating, the less impact it has on the environment.

Your current rating is **band E (53)**. The average rating for EPCs in Scotland is **band D (59)**.

The potential rating shows the effect of undertaking all of the improvement measures listed within your recommendations report.
